THE ROLE OF BIOFILMS AND LICHENS IN THE PRESERVATION OF ARCHAEOLOGICAL FEATURES IN THE BANDELIER TUFF, BANDELIER NATIONAL MONUMENT

Case hardened surfaces that develop over tuff outcrops in Frijoles Canyon (Bandelier National Monument, New Mexico, USA) are a combination of biotic and abiotic crusts that contribute to the preservation of ancient anthropogenic features carved in the cliffs. This study shows that in the initial stages of crust development, lichens and other surface biota cement wind-blown and water-transported particles to the rock face and reinforce and stabilize the accumulated clay / silt coatings. Abiotic crusts form on canyon walls by the partial dissolution of the tuff in the near-surface zone, followed by precipitation of secondary minerals that form a durable cement. We conclude that acid excretions from cyanobacteria and lichens colonizing the surface act to catalyze tuff dissolution. The resulting case hardened surfaces are more erosion resistant than the underlying rock, and protect the fragile prehistoric rock-cut dwellings (cavates), features, and petroglyphs left by the ancient Pueblo people. In conducting the study, researchers have considered whether l

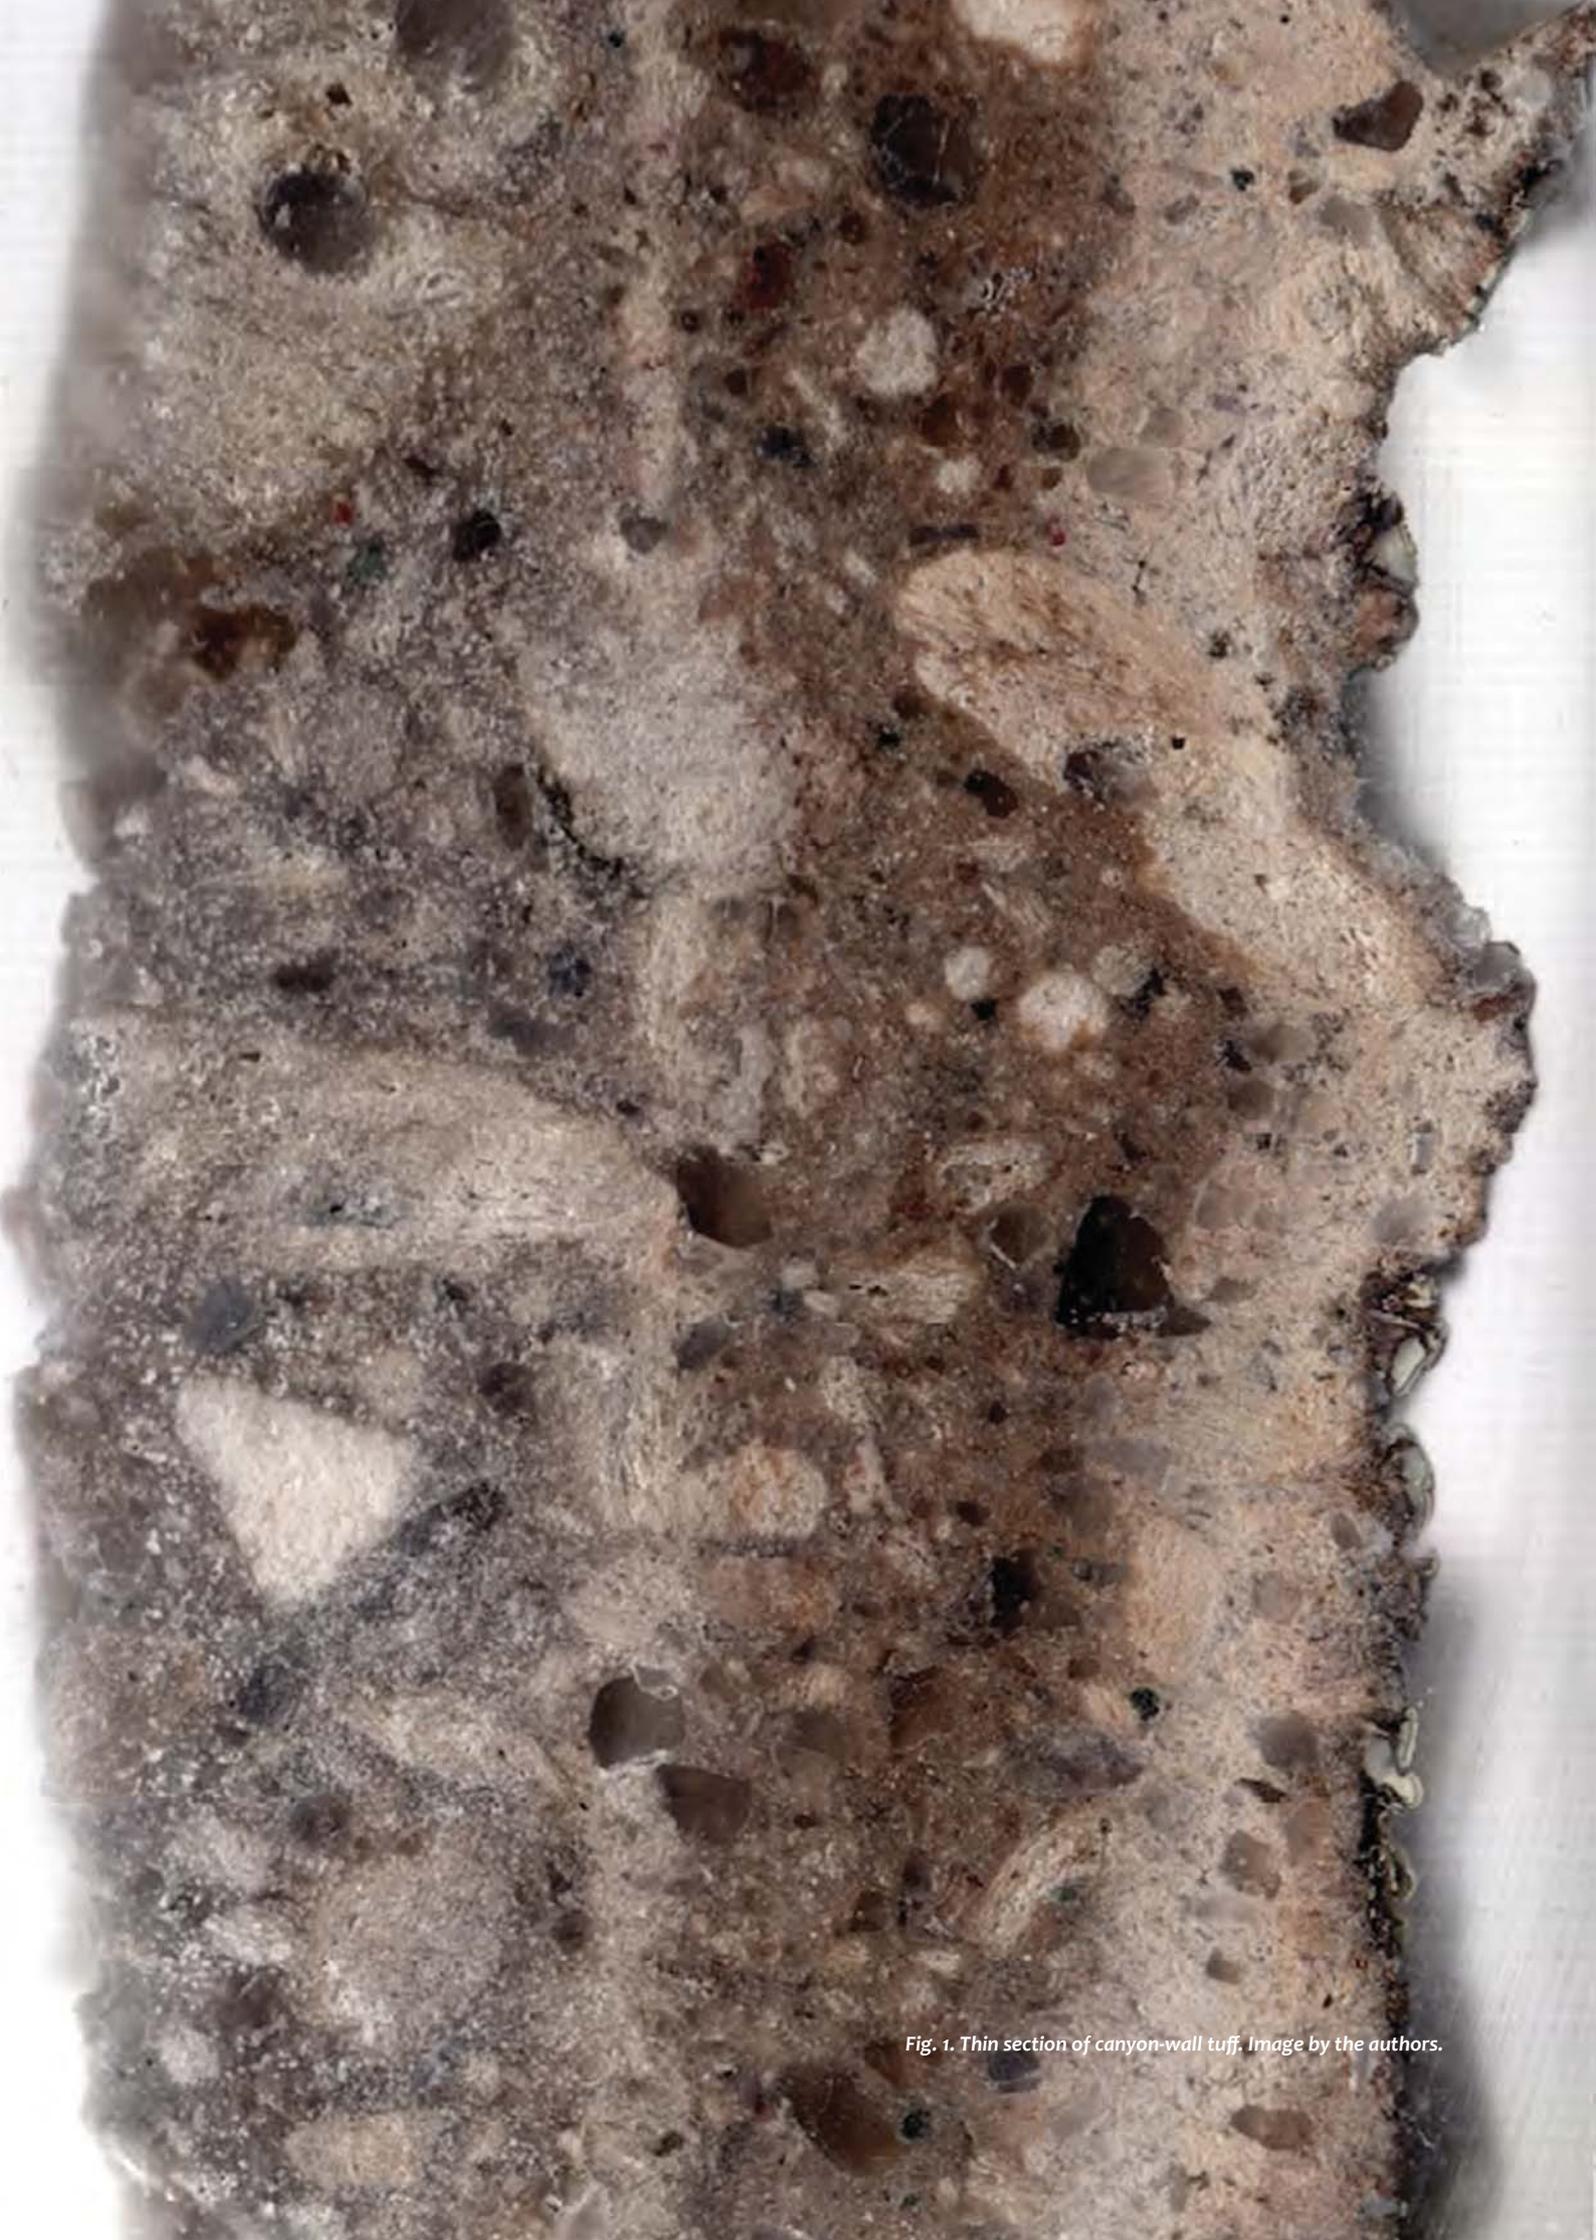
Fig. 1. Thin section of canyon-wall tuff. Image by the authors.

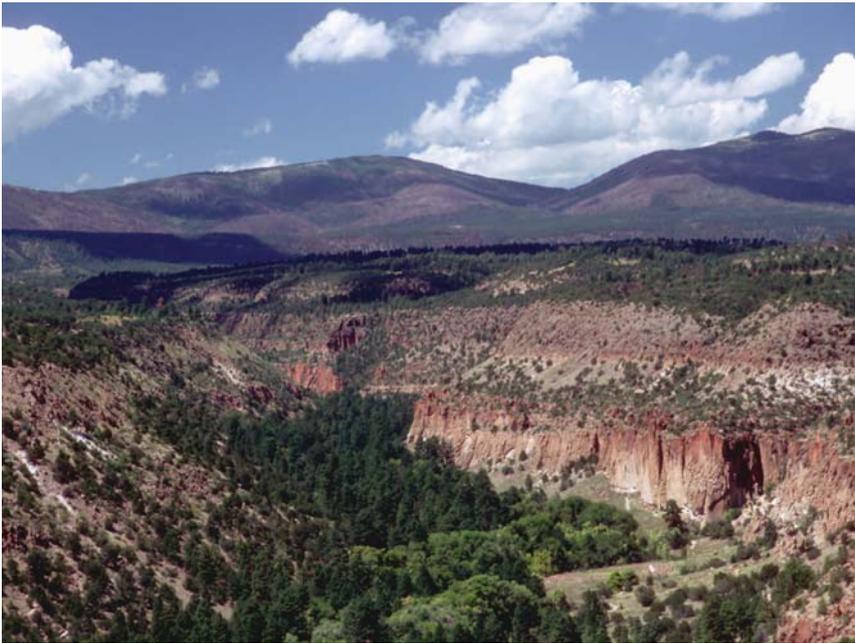
Fig. 2. Frijoles Canyon in Bandelier National Monument, where there are over 1000 cavates in a 2 km-long section of the canyon. The mountains in the background give the general location of the Toledo and Valles calderas that spewed ash forming the Bandelier Tuff approximately 1.6 and 1.2 million years ago. Over 300,000 people a year visit this canyon to explore the cavates.

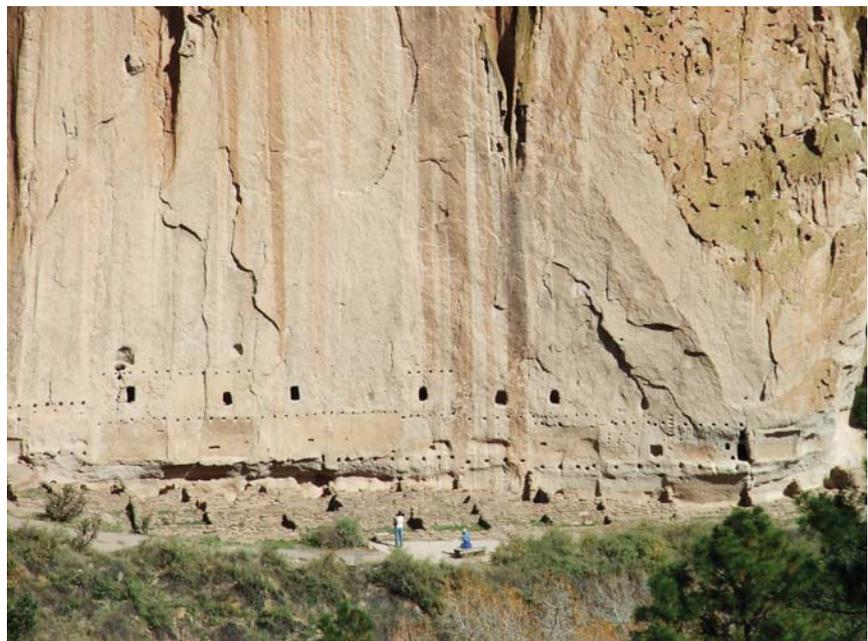
Fig. 3. Long House Pueblo at Bandelier National Monument. From the visitor trail one can see cavates carved into the poorly consolidated Qbt1g subunit of the Bandelier Tuff, along with viga sockets that supported wood roof members in the masonry rooms that formed the front of the pueblo. These rooms are in ruins (photo foreground), and earthen plasters that finished the room interiors is visible on the outcrop surface (below the viga sockets). Note the case-hardened surfaces, especially on the upper right; this research is focused on the processes of their formation. Photo credit: Western Mapping Co.

and special-purpose rooms. They are the ancestral dwellings of the Native American Pueblos that still live in the region (Fig. 3).

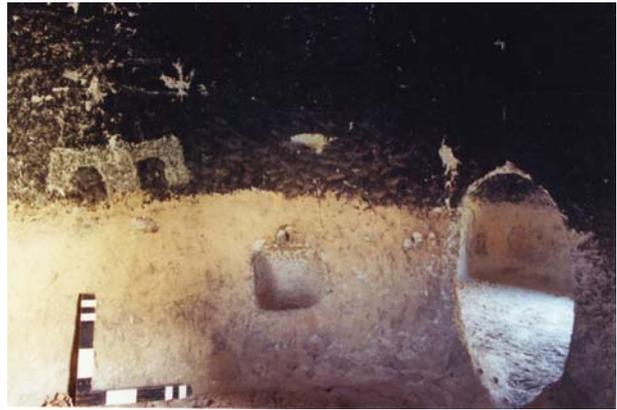
Fig. 4. Inside the cavates are numerous built-in features to produce and store food and to weave fabric. This is the only place where the domestic details of the lives of the prehistoric Pueblo people are still visible. Cavate interiors are often sooted and plastered with up to 30 layers earthen plaster, some of them decorated with painted and incised designs.

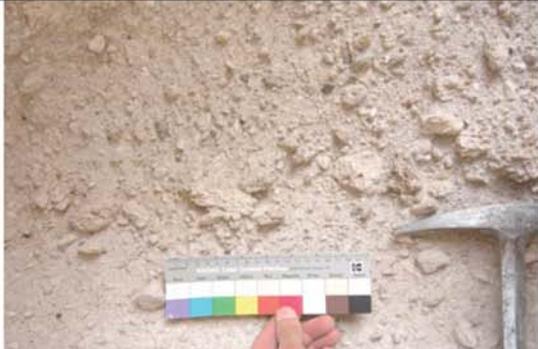
Type 1

<ul style="list-style-type: none"> • Freshly exposed, apparently unaltered tuff • White to light gray in color • Rough texture with prominent pumices • Little to no sedimentation of silt-clay or calcite visible on surface • Easily abraded with light pressure • Fine glassy ash in the tuff matrix is abundant and unaltered • Matrix porosity is high (40-50%) • Secondary minerals are absent to rare
Type 2

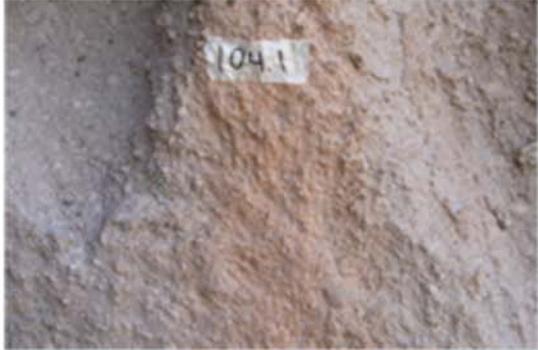
<ul style="list-style-type: none"> • Sedimented silt-clay coating over freshly exposed tuff • Coating is very thin, resembling a wash, and is often in runnels down the tuff surface • Filamentous cyanobacteria frequently found to have colonized this surface coating • Fine glassy ash in the tuff matrix is abundant and unaltered • Matrix porosity is high (40-50%) • Secondary minerals are absent to rare
Type 3

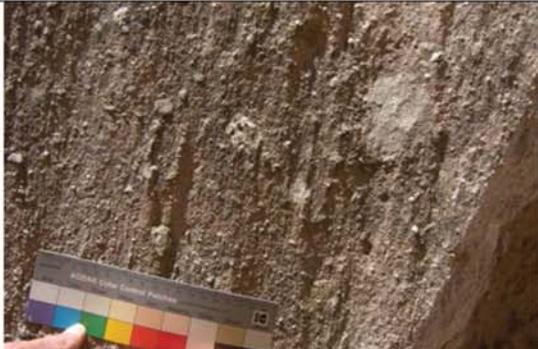
<ul style="list-style-type: none"> • Black biofilm layer overlaying exposed tuff • Silt-clay coating / lichen cover are less prominent surface features • Moderately indurated and resistant to erosion • Alteration is sporadic and generally limited to a zone 0.1 to 0.5 cm thick • Porosity remains high where the tuff is little altered, but in heavily mineralized areas is reduced to 20 to 30%

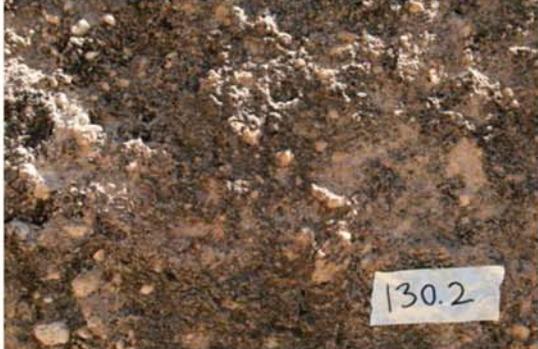
Type 4

<ul style="list-style-type: none"> • Lichens and other biogrowth appear over a prominent silt-clay coating • Crustose lichens are more plentiful than in other surface types • Moderately indurated and resistant to erosion • Alteration is sporadic and generally limited to a zone 0.1 to 0.5 cm thick • Porosity remains high where the tuff is little altered, but in heavily mineralized areas is reduced to 20 to 30%
Type 5

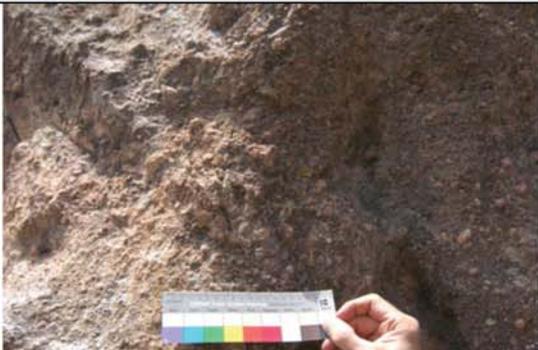
<ul style="list-style-type: none"> • Generous lichen distribution, often accompanying a thick silt-clay coating • Comparatively smooth texture, lacking the large surface asperities that are typical of Types 6 and 7 • Moderately indurated and resistant to erosion • Alteration is sporadic and generally limited to a zone 0.1 to 0.5 cm thick • Porosity remains high where the tuff is little altered, but in heavily mineralized areas is reduced to 20 to 30%

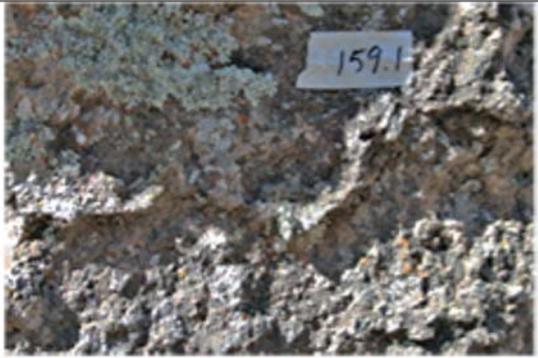
<p>Type 6</p>

<ul style="list-style-type: none"> • Well developed lichen growth • Surface is rough, with asperities in the range of 1-3cm • Abrupt changes in surface level at losses, with crust thickness of up to 4 cm • Strongly indurated, with crusts that are generally 1 to 1.3 cm thick • Case hardened zone is commonly made up of two parallel bands of alteration • Porosity for the inner alteration band commonly <5%
<p>Type 7</p>

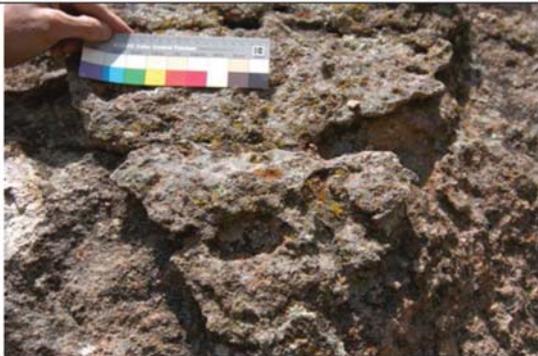
<ul style="list-style-type: none"> • Well developed lichen growth, with greater biocommunity diversity • Severely eroded, with surface asperities in the range of 1-6cm • Examples have prominent edges with crust thickness of up to 6 cm • Strongly indurated, with crusts that are generally 1 to 1.3 cm thick • Case hardened zone is commonly made up of two parallel bands of alteration • Porosity for the inner alteration band commonly <5%

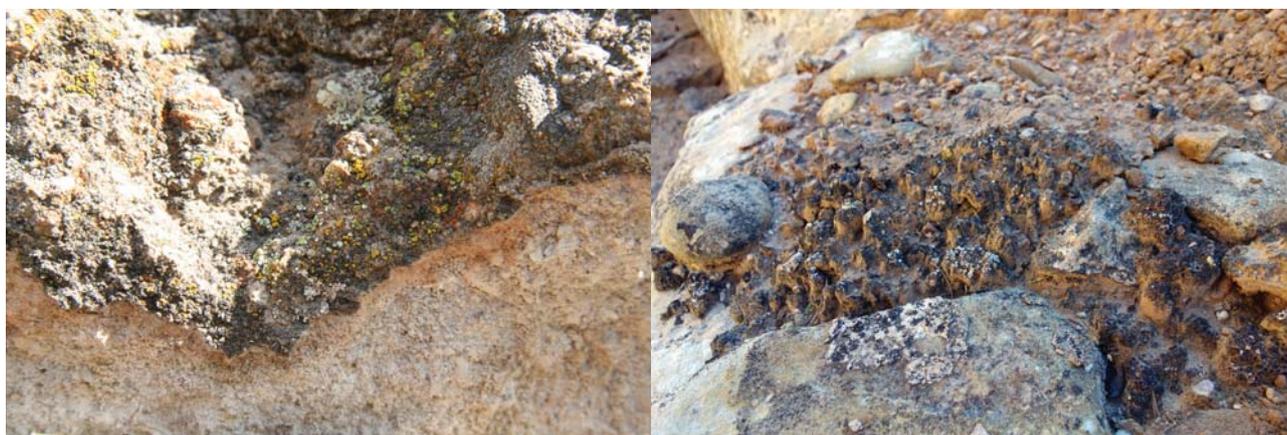
Fig. 9. The case hardened tuff surface (left) includes a silt-clay layer colonized by lichens. Note the similarities in surface topography and patina to the biological soil crust on the right.

Modification of canyon wall surfaces and development of a hard surface coating or rind (case hardening) involves three main components. 1) deposition of sedimented particulates on exposed tuff surfaces; 2) growth of lichens and microflora on (and in) exposed tuff surfaces and on the sedimented layers that coat them; and 3) bio-geochemical reactions that lead to the dissolution of volcanic glass and precipitation of secondary minerals (Fig. 9).

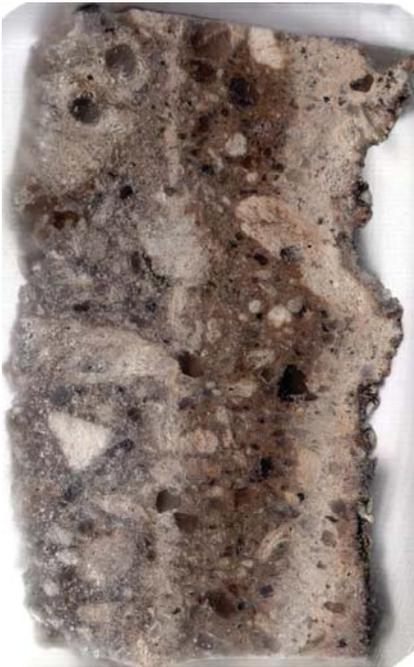
Fig. 16. Canyon-wall tuff with Type 7 alteration. The image is a thin section butt 2.5 cm wide cut perpendicular to the canyon wall. The canyon wall is on the right side of the image. The case hardened zone is made up of two parallel bands of alteration. The outer alteration band, next to the canyon wall, is mostly white in color. The inner alteration band ranges is medium to dark brown in color. Both bands are extensively altered, but the inner band is more highly mineralized. The tuff left of the inner band of alteration is slightly altered and contains abundant volcanic glass. Porosity is 20 to 30% in the outer band, 1 to 15% in the inner band, and 30 to 40% in the slightly altered tuff.
