*Human Activity as the Primary Indicator of Increased Frequency and Spatial Distribution of Landslides on
Riverside Avenue in Burlington, Vermont, 1928 - 2019.*

Hehlen, Mark. Long, Grant. Robinson, Emma. Silvia, Kate.
Fall 2020 Geomorphology
University of Vermont

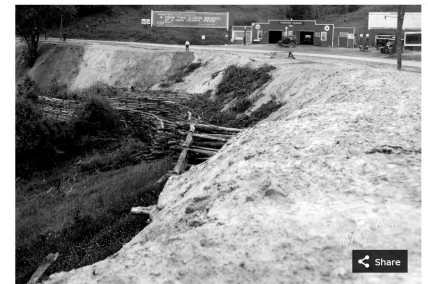
Figure 2: Rebuilding a section of Riverside Ave.

Circa 1936: Efforts to stabilize and widen Riverside Avenue in Burlington included a wooden grid structure and a great deal of sand and gravel fill, as seen in this photograph by L.L. McAllister. The Fairview Garage and gas station can be seen in the road's deep curve.
SPECIAL COLLECTIONS, BAILEY/HOWE LIBRARY, UNIVERSITY OF VERMONT

The first reported landslide on Riverside Avenue occurred sometime during 1928. After this event, in the 1930s, anthropogenic geomorphological impacts on the area began as Riverside Ave was expanded and paved by filling the downslope side with sand and gravel (**Figure 2**). Circa 1937 the area was approved by the state of Vermont for development into a residential area. Following the approval, Vermonters began to build into the area, deforest the slopes, and fill ravines, decreasing soil cohesion and reducing slope stability.

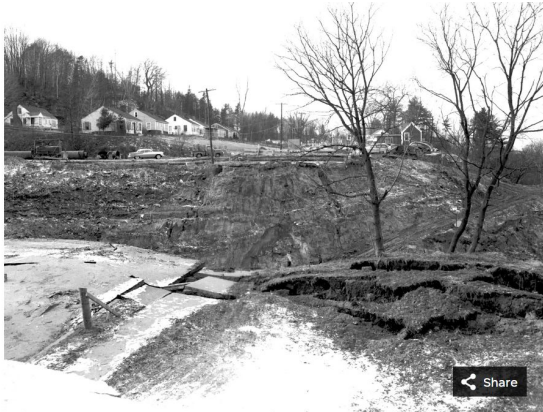
Figure 3: 1955 landslides

A massive 1955 collapse of the hillside beneath Riverside Avenue in Burlington closed the road and literally undermined decades of work to stabilize the slope. This photograph was taken Dec. 8, 1955 by James Detore to document damage for the American Fidelity insurance company.

In 1948 topography changed in the area as the ravines were filled in order to make room for future housing developments and a large landfill on the south side of the avenue. In 1955 two known landslides took place at what is now the intersection of Riverside Avenue and Hillside Terrace (**Figure 3**). The first of the slides is attributed to excess soil saturation from an abandoned drainage culvert. Riverside Avenue required major repairs after a massive washout, diverting the road through the landfill. The second landslide occurred from toploading of excavation soils, overburdening the crest of the slope to the point of failure. In 1960 the landfill was dug up and cleared out, in order to make room for housing developments (see 1962 aerial photo in **Figure 4**) increasing rainfall runoff in the area.

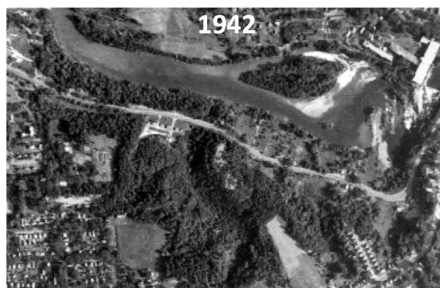
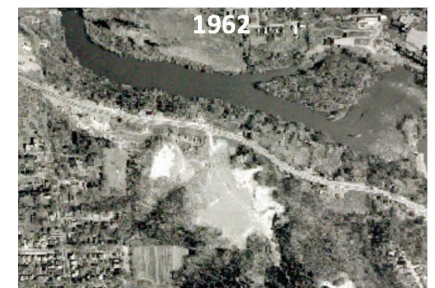
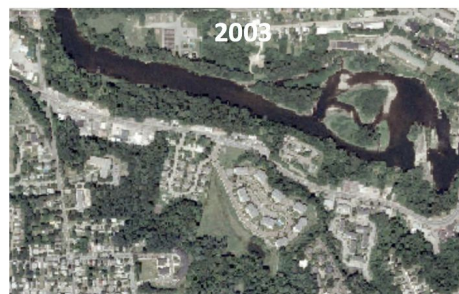
Figure 4: Three photos showing Riverside Avenue land development from 1942 - 2003. Shows well forested Riverside Ave in 1942 some development on the eastern side of the road, followed by 1962 where there is extensive deforestation making room for residential development. The 2003 photo shows development on both sides of the road with well forested hillslopes.

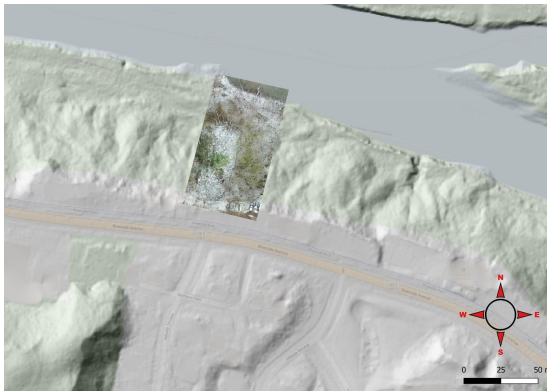
Figure 7: Drone imaging of the 2019 landslide layered on LiDAR digital elevation model of Riverside Avenue

We Investigated the site of the 2019 Halloween landslide to gather *in situ* measurements of slope angle, debris field volume, and using orthographic LiDAR data to map the spatial extent of the scarp (Figures 7&8). Landslides occur when the driving force supersedes the resisting force. This happens to stable slopes when rainfall or runoff events increase pore pressure in soils counteracting normal forces. Using an infinite slope model these are given by:

The area of the 2019 landslide covers nearly 3500 m² on a 30° slope. An equal sized area of backfilled and paved property sits above and drains toward it, doubling the rainfall associated with the saturated region of the slope. By measuring the debris field volume we can estimate the slab displacement. Averaging the densities of sand, clay and gravel (fill material) we find mean dry density equal to 1600 Pa and wet density equal to 1888 Pa. This allows us to infer the cohesion factor of the slope before failure; in this instance, 1.3 kPa, well below the standard 12 kPa of soil cohesion for a forested slope.

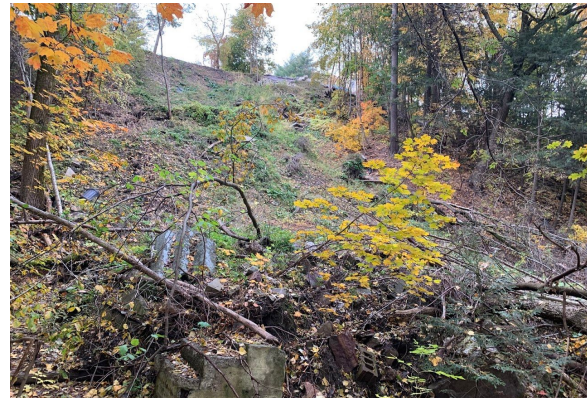
Figure 8: Site of the “Halloween” landslide. Photo taken in Oct 2020

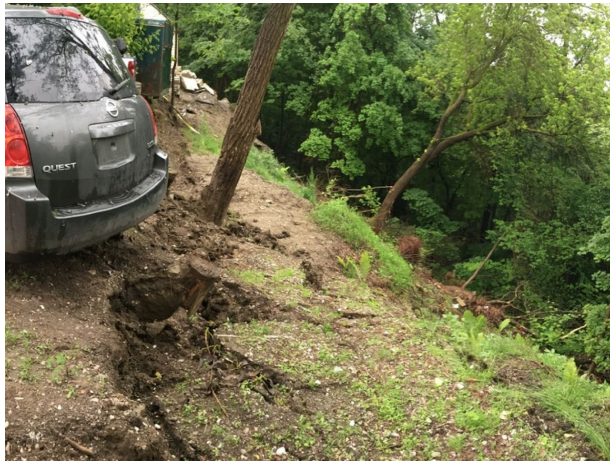
Figure 9: Soil cracks and slumping visible on the slope at the site of the 2019 landslide months prior to failure
