*Human Activity as the Primary Indicator of Increased Frequency and Spatial Distribution of Landslides on
Riverside Avenue in Burlington, Vermont, 1928 - 2019.*

Hehlen, Mark. Long, Grant. Robinson, Emma. Silvia, Kate.
Fall 2020 Geomorphology
University of Vermont

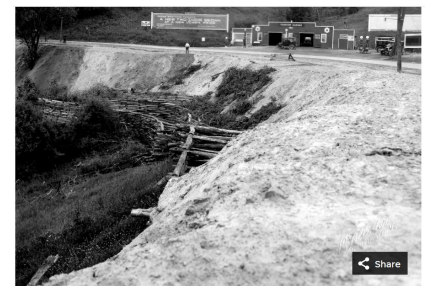
Figure 2: Rebuilding a section of Riverside Ave.

Circa 1935: Efforts to stabilize and widen Riverside Avenue in Burlington included a wooden grid structure and a great deal of sand and gravel fill, as seen in this photograph by L.L. McAllister. The Fairview Garage and gas station can be seen in the road's deep curve.
SPECIAL COLLECTIONS, BAILEY/HOWE LIBRARY, UNIVERSITY OF VERMONT

The first reported landslide on Riverside Avenue occurred sometime during 1928. After this event, in the 1930s, anthropogenic geomorphological impacts on the area began as Riverside Ave was expanded and paved by filling the downslope side with sand and gravel (Figure 2). Circa 1937 the area was approved by the state of Vermont for development into a residential area. Following the approval, Vermonters began to build into the area, deforest the slopes, and fill ravines, decreasing soil cohesion and reducing slope stability.

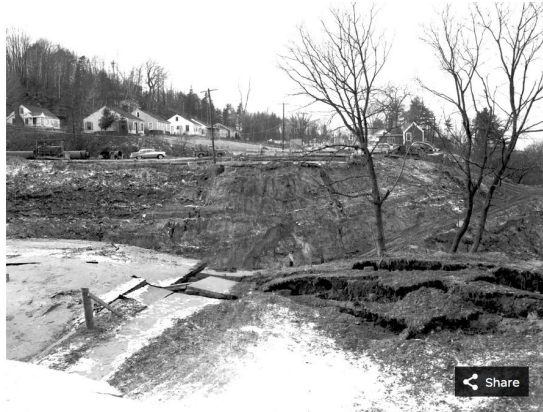
Figure 3: 1955 landslides

A massive 1955 collapse of the hillside beneath Riverside Avenue in Burlington closed the road and literally undermined decades of work to stabilize the slope. This photograph was taken Dec. 8, 1955 by James Detore to document damage for the American Fidelity insurance company.

In 1948 topography changed in the area as the ravines were filled in order to make room for future housing developments and a large landfill on the south side of the avenue. In 1955 two known landslides took place at what is now the intersection of Riverside Avenue and Hillside Terrace (Figure 3). The first of the slides is attributed to excess soil saturation from an abandoned drainage culvert. Riverside Avenue required major repairs after a massive washout, diverting the road through the landfill. The second landslide occurred from toploading of excavation soils, overburdening the crest of the slope to the point of failure. In 1960 the landfill was dug up and cleared out, in order to make room for housing developments (see 1962 aerial photo in Figure 4) increasing rainfall runoff in the area.

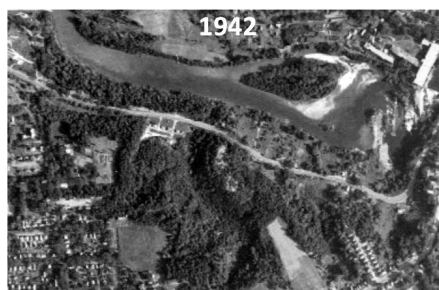
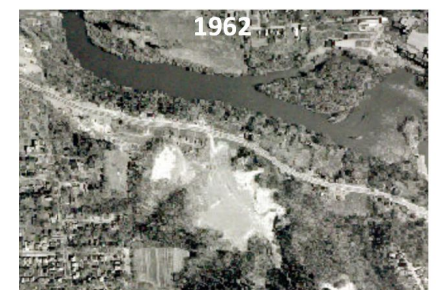
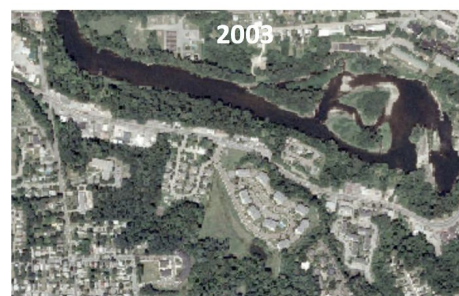
Figure 4: Three photos showing Riverside Avenue land development from 1942 - 2003. Shows well forested Riverside Ave in 1942 some development on the eastern side of the road, followed by 1962 where there is extensive deforestation making room for residential development. The 2003 photo shows development on both sides of the road with well forested hillslopes.

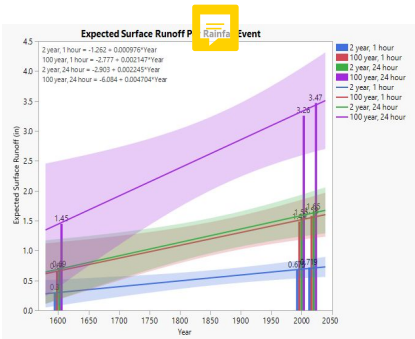
Figure 5: Expected Burlington area rainfall runoff event correlated through time with increased population and development

In late October of 2019, a decadal scale large storm (**Figure 5**) led to rainfall in the Burlington area of 3.3 inches over a 24 hour period. Storm runoff is exacerbated by paving, building development, and slope toploading. These factors led to slope saturation and the ‘Halloween’ landslide of 2019, downslope of the Hillside Terrace intersection (the same site as the 1968 landslide), and a smaller adjacent slide behind 465 Riverside Ave. A spatial and temporal distribution of a century worth of landslides on Riverside Avenue is given in **Figure 6**.

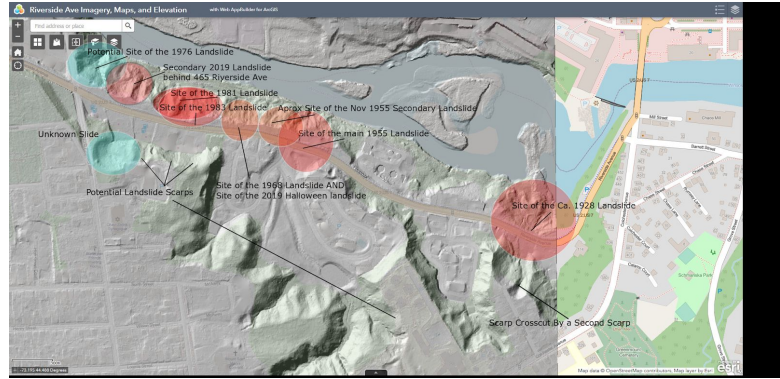
Figure 6: Distribution of recorded landslides on Riverside Avenue 1928-2019

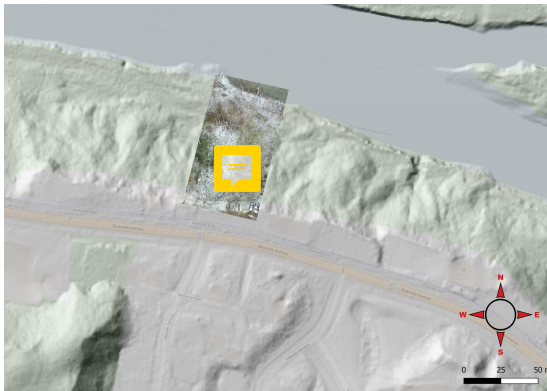
Figure 7: Drone imaging of the 2019 landslide layered on LiDAR digital elevation model of Riverside Avenue

We Investigated the site of the 2019 Halloween landslide to gather *in situ* measurements of slope angle, debris field volume, and using orthographic LiDAR data to map the spatial extent of the scarp (Figures 7&8). Landslides occur when the driving force supersedes the resisting force. This happens to stable slopes when rainfall or runoff events increase pore pressure in soils counteracting normal forces. Using an infinite slope model these are given by:

The area of the 2019 landslide covers nearly 3500 m² on a 30° slope. An equal sized area of backfilled and paved property sits above and drains toward it, doubling the rainfall associated with the saturated region of the slope. By measuring the debris field volume we can estimate the slab displacement. Averaging the densities of sand, clay and gravel (fill material) we find mean dry density equal to 1600 Pa and wet density equal to 1888 Pa. This allows us to infer the cohesion factor of the slope before failure; in this instance, 1.3 kPa, well below the standard 12 kPa of soil cohesion for a forested slope.

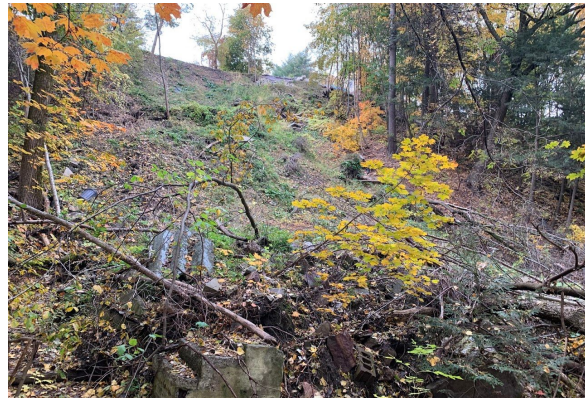
Figure 8: Site of the “Halloween” landslide. Photo taken in Oct 2020

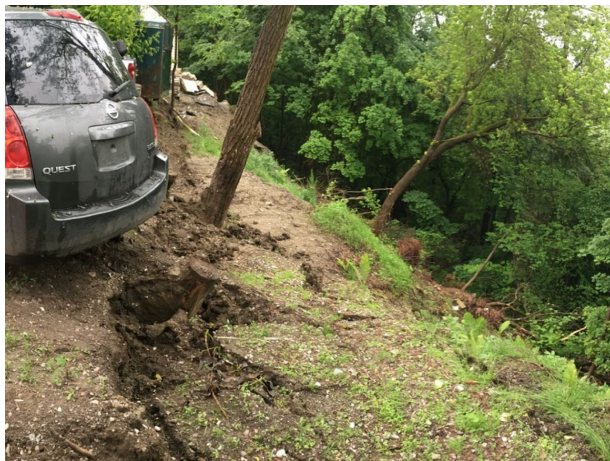
Figure 9: Soil cracks and slumping visible on the slope at the site of the 2019 landslide months prior to failure
