Landslides along the Winooski River in Burlington, Vermont: Landscape change and slope instability

Shayla Triantafyllou, Anne Morrison, Emily Mischler, Jason Drebber
Department of Geology, University of Vermont, Burlington, VT, USA

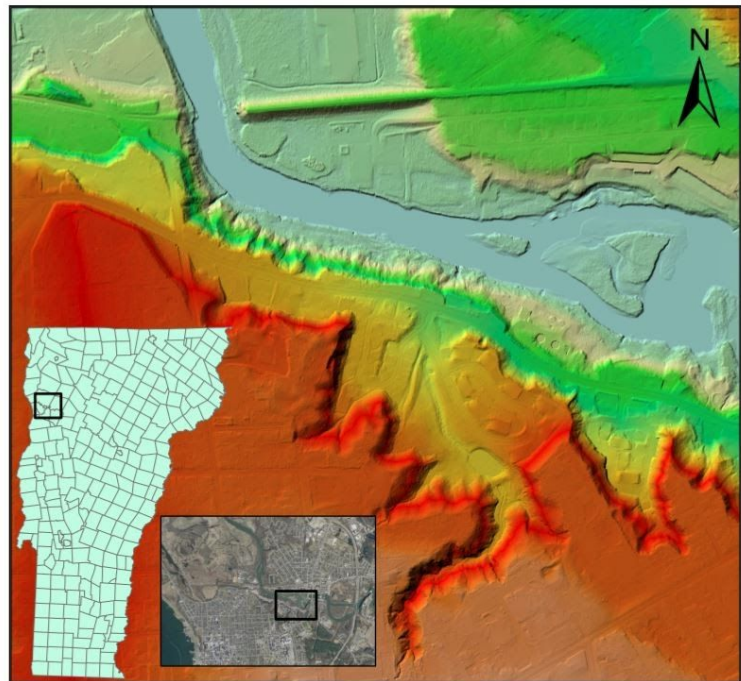
Figure 1. Shaded relief map of the study area. Inset of location within Burlington and Vermont. Amphitheatre shaped landslides are clearly visible along the bank of Riverside Avenue.

We investigated causes of landsliding along Riverside Avenue in Burlington Vermont (Figure 1). As a main road running parallel to the river, Riverside Avenue is important for businesses, homes, and transit. We aim to understand how hydrogeology, runoff, and surficial geology control landslides along Riverside Avenue.

River channel morphology and human landscape change are two primary controls on the spatial distribution of landslides here (Fig. 1). Already narrow and steep river margins were worsened by development. Human induced landscape change results in a higher amount of runoff, decreasing cohesion and changing slope stability force balance equations (Fig. 2). Upstream of Riverside Avenue, the channel is confined by bedrock and the level ground is made up of ancient terraces (Wright).

We discovered a substantial increase in paved and other impervious surface area over the past century coinciding with increased urbanization (Nichols et al., 2003). Artificial surfaces decrease infiltration which increases runoff. The site's drainage basin topography is depicted in Figure 1. Impervious surfaces from new developments intensify runoff volume and speed as it flows towards the site. Approximately 757,664 ft² of Riverside Avenue and surrounding neighborhoods within this drainage basin consist of paved or impervious surfaces (Fig. 4). Shifts in runoff response due to changes in land use are visible in a basin's hydrograph (Hackett, 2008). The October 2019 storm (Fig. 5) triggered the most recent landslide. The Winooski River hydrograph looks "flashy," showing a sharp increase in discharge over a relatively short time period, especially for a drainage basin over 2700 km² (Fig. 5). Hydrographs of this nature correspond with basins that are less permeable, as infiltration allows for a more gradual peak. This rain event was key in destabilizing the Riverside Avenue slope on November 1, 2019.

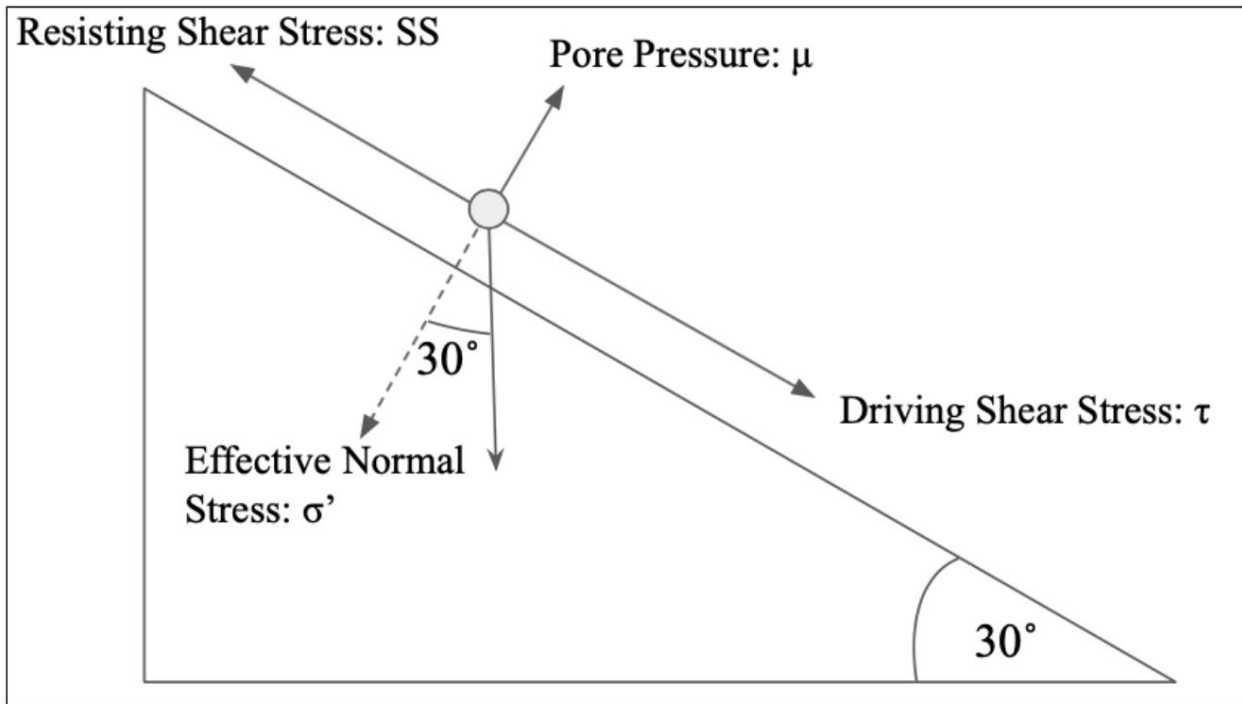
Figure 2. Slope stability force diagram. Vectors represent 4 principle forces contributing to the stability of a slope. Unbalanced vectors indicate greater driving shear stress than resisting shear stress and likely slope failure of a slope with failure plane 30° above horizontal. See Appendix for further explanation. Figure adapted from Bierman and Montgomery.

The driving shear stress increases with increasing density and slope thickness. Dumping of additional fill and trash contributes to this force vector. Evidence of this was recorded by Paul Bierman (Bierman, Personal Communication) prior to the 2019 landslide. Past landslides have been triggered by dumping additional fill or construction waste onto the slope (Reilly, 1981). Any event that causes the driving shear stress to exceed the resisting shear stress will result in slope failure (Fig. 2).

Groundwater hydrology plays an essential role in landslides. Water table height (h), is linearly related to pore pressure within soil (See Appendix). Pore pressure opposes effective normal stress, so increases in water table height destabilize slopes (Fig. 2). Large precipitation events provide a catalyst for this. Most recently the October 31st, 2019 storm (Fig. 5) saturated the soil past a threshold triggering a landslide. Additionally, an increase in the groundwater height will reduce the effect soil density has on resisting slope failure (See Appendix).

Force Diagram Equations

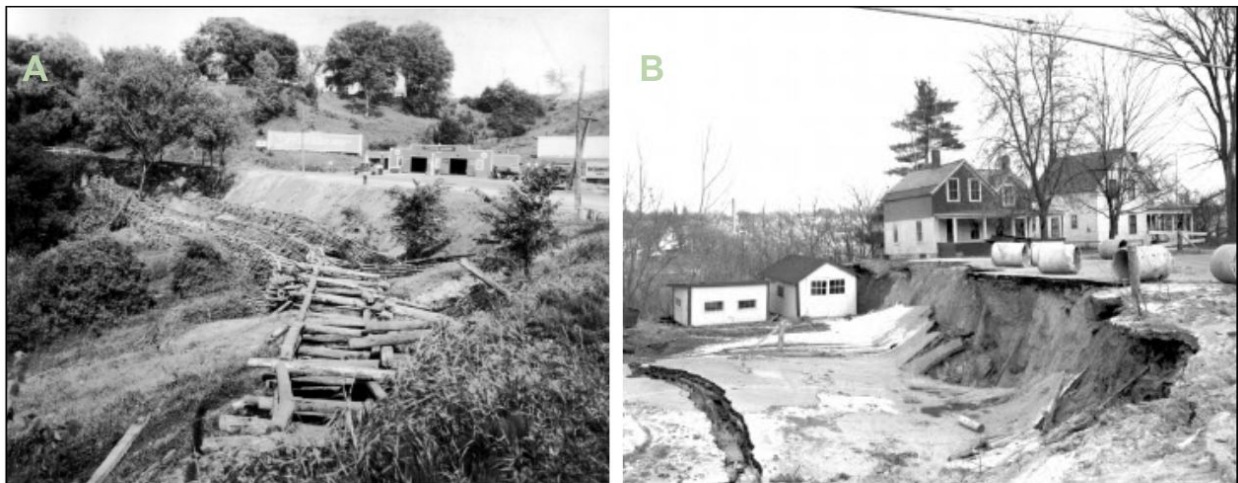
Figure 3: Historic images of Riverside Ave (Source: uvm.edu/landscape). Image A depicts road widening with wooden shorings and fill in progress between 1930 and 1955. Image B is of the 1955 landslide.

Glacial history, hydrology, and human induced changes all contribute to landsliding along Riverside Avenue. Significant road work began in 1930; filling and widening the road by over five feet (Fig. 3A, *Street Department, 1931*). Historical aerial photos reveal houses, businesses, and parking lots constructed on both sides of the road between 1930 and 1955 prior to the first documented landslide in 1955 (Fig. 3B). The issue was exacerbated in the late 1970s and early 1980s when trash was illegally dumped down the slope between the road and river (Melvin, 1983). Fill is incohesive and decreases slope stability by creating a lower angle of internal friction as well as limiting drainage, causing the water table to rise.

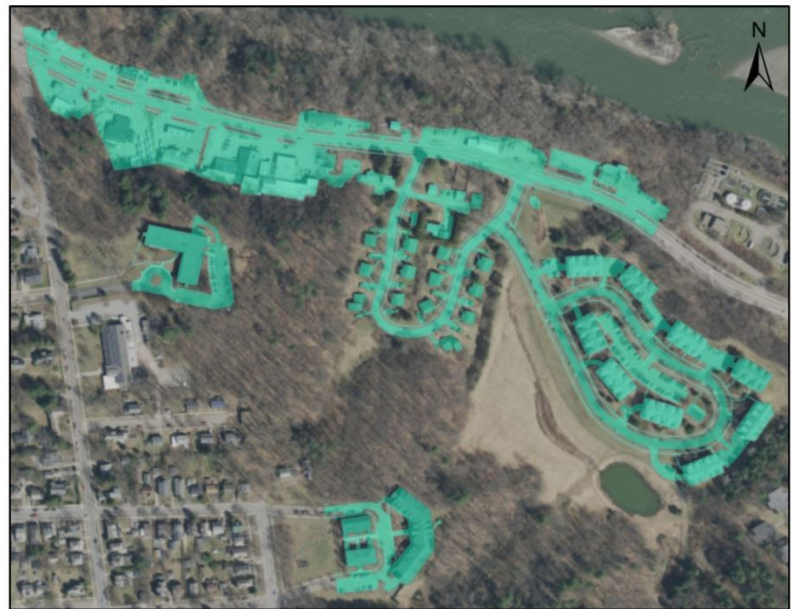
Figure 4: Map of impervious surfaces on Riverside Avenue contributing to high volumes of runoff within the study area.

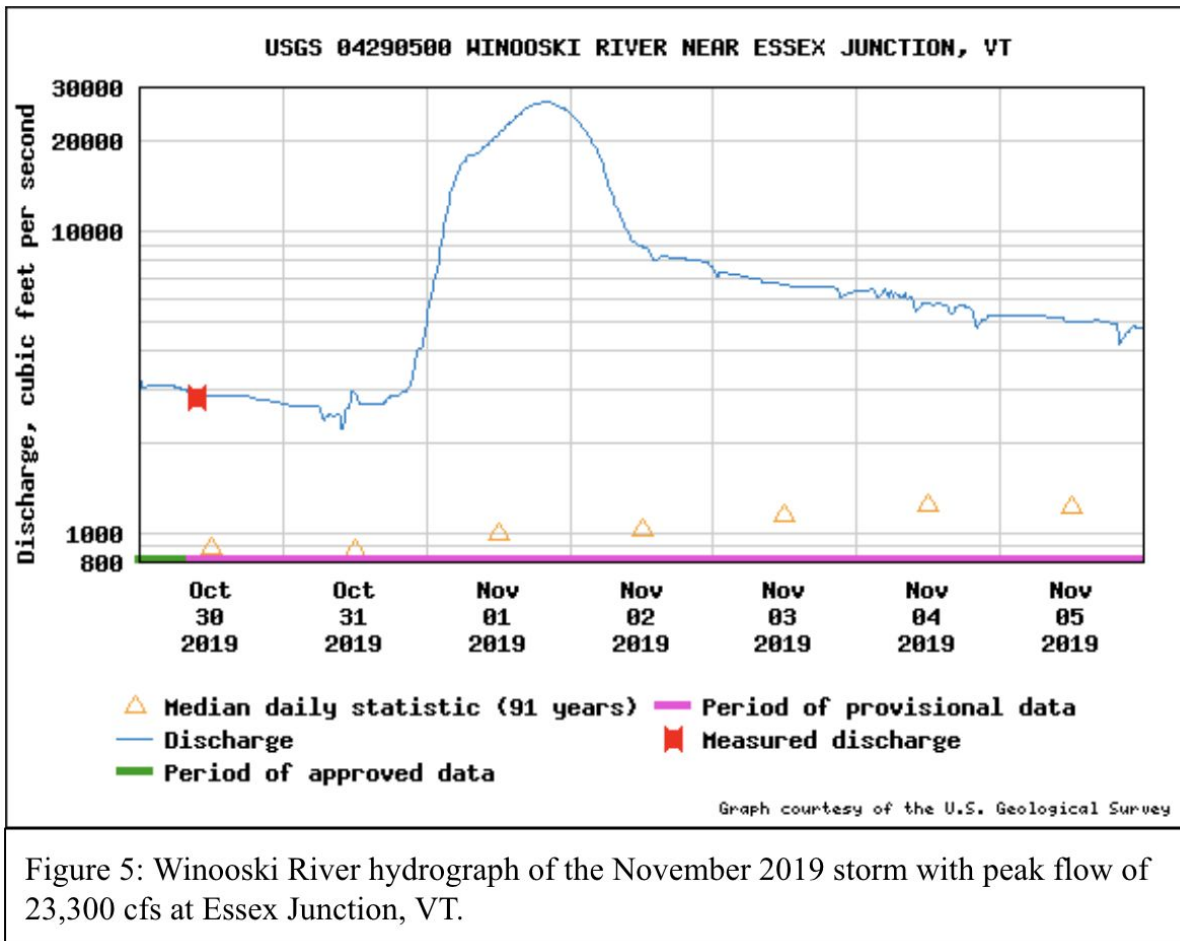
Figure 5: Winooski River hydrograph of the November 2019 storm with peak flow of 23,300 cfs at Essex Junction, VT.

The most recent landslide at Riverside Avenue was triggered by an intense precipitation event (Fig. 5). While this storm was large across Vermont, it had a recurrence interval of only 3.44 years at the Essex Junction stream gage. There is a 29% chance of this event occurring in any given year. Simple models show that the hillslope along Riverside Avenue surpass threshold conditions resulting in slope failure. We should prepare for more frequent landslides. Based on our analysis, solutions must be implemented immediately.
