Riverside Avenue Landslides

Harrison Hurwitz, Leah Sutphen, Remy Farrell, Ryan Mistur

What controls landslide spatial distribution along Riverside Avenue?

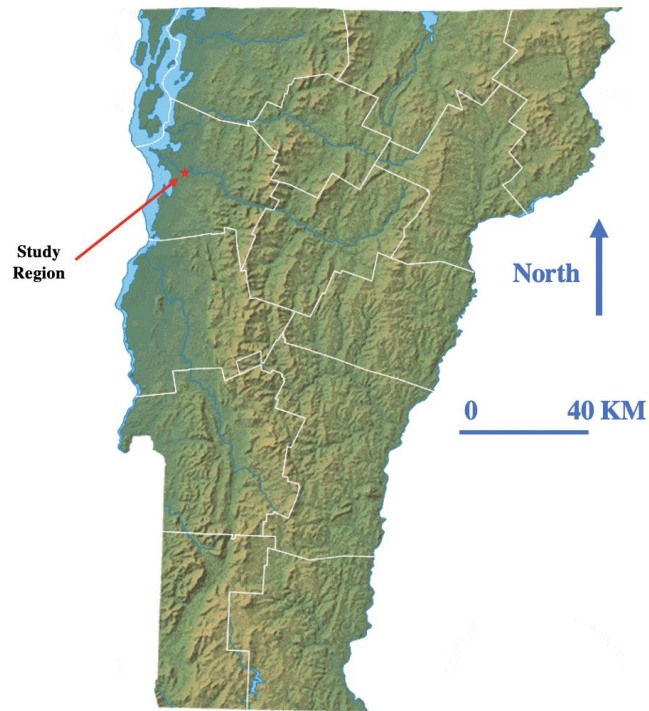
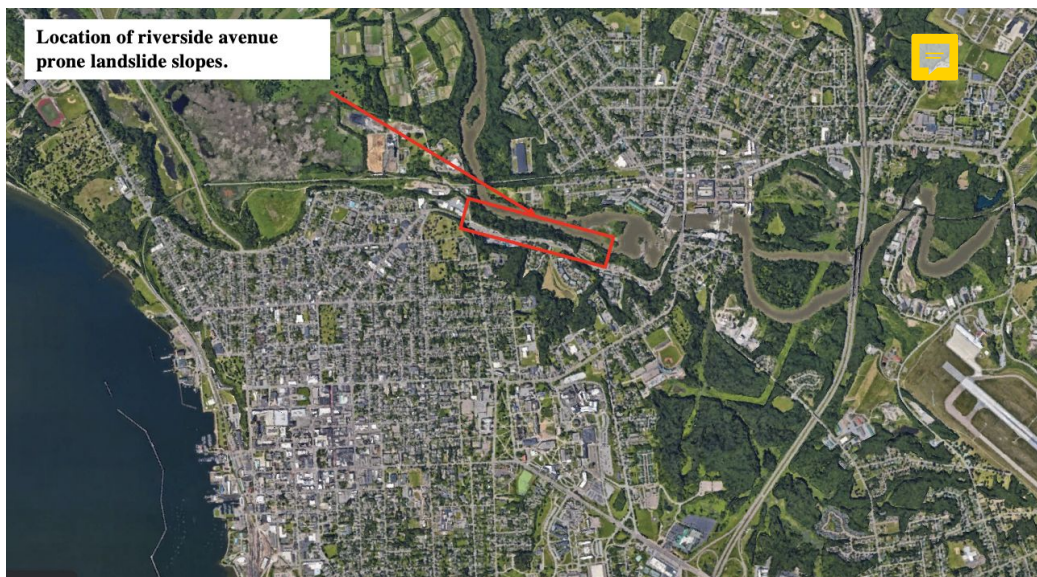
Figure 1.

Figure above shows a map of Vermont, the red star indicates the study region within the state. The aerial photo below shows the city of Burlington and Winooski VT, with the narrow slope between Riverside Avenue and the Winooski river indicated. The red indication shows the area of past and active landslides alongside the busy street.

on proximity, compaction of permeable surfaces, and unauthorized filling near/on the slope. (Fig. 1) Ground and surface water assessment should be done on runoff from the impermeable road above and the unknown culverted drainage pipes

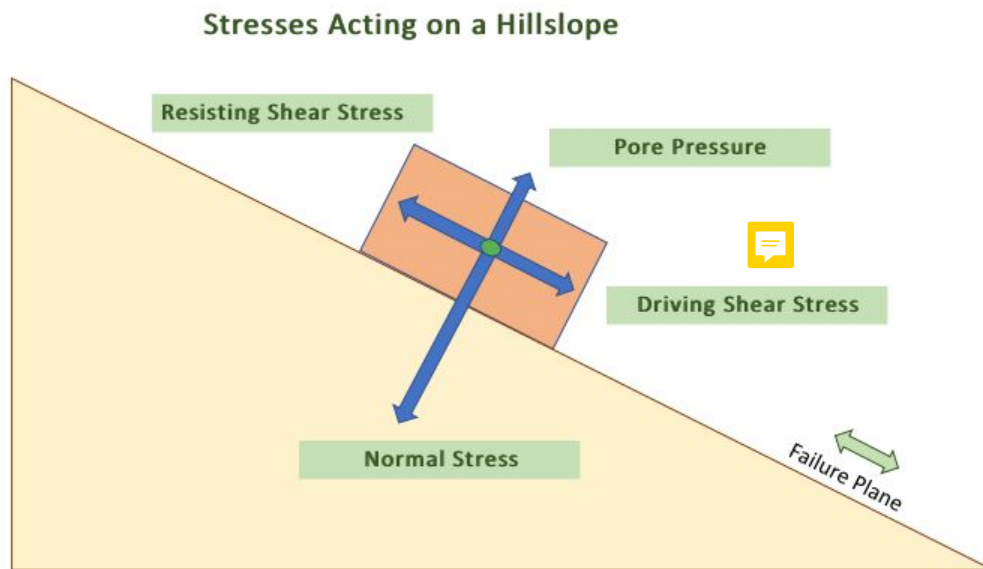
Figure 3.
 The figure above depicts the relationship between resisting shear stress, driving shear stress, pore pressure, and normal stress. These active stresses and their relationship with one another determine the likelihood of a landslide occurring. Landslides occur when the driving shear stress exceeds the resisting shear stress, which can be triggered by many factors.

Landslides are earth hazards that have multiple possible triggers. These triggers ultimately disturb the slope stability so much so that the driving shear stress exceeds that of the resisting shear stress, resulting in material traveling down the hill slope (as seen in Figure 3). Slope stability can be disturbed by decreasing soil cohesion, excessive and sudden influx of water, and gravity's force over time. Soil cohesion is compromised by deforestation, soil removal, and excessive filling of loose material. Deforestation rids soil of tree roots, which act as a stabilizer and provide cohesion. Soil removal makes the soil less compact, and filling those holes with loose sediment perpetuates the instability. Loose sediment fill does not have the porosity or cohesive ability to sustain a hill slope with strong soils. A sudden influx of water can occur with heavy rainfalls and snow melt, which can decrease infiltration rates and increase the runoff down the slope. This water can bring other material down the slope and could potentially trigger a landslide. Gravity causes soil creep over time, which is the slow, episodic movement of material down slope. Falling trees can carry other materials with them, eventually accumulating to an amount that allows the driving force to exceed the resisting force. Landslides can be triggered by many different things in many different ways, and always involve an unstable hill slope.

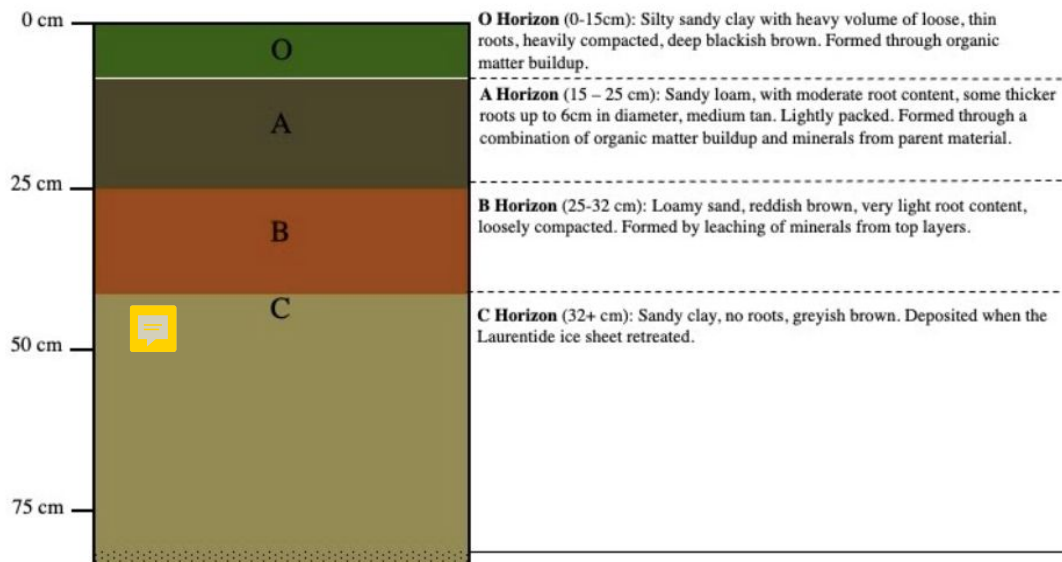
Figure 4.

Riverside Ave Timeline

Are they human-induced? (timeline figure)

We observe decades of evidence of this repeated cycle with at least five landslide events and reconstruction attempts. At the banks of the river, there are still old appliances, large boulders, sand, silt, gravel, as well as debris, from the illegal dumping in June 1981. The

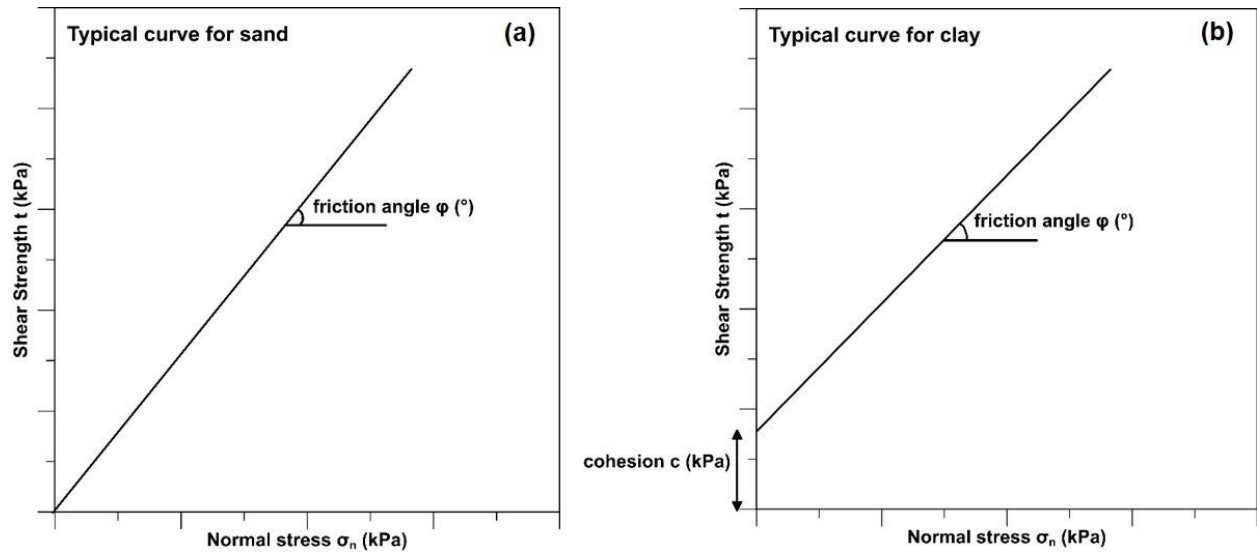
Figure 5.

Figure above shows two plots (a) which is the curve for sand giving a shear strength t (kPa) plotted against the normal stress (kPa) and (b) the curve for clay with the same variables plotted. Notice the cohesion c (kPa) value for clays, which has an internal shear strength t at 0.

The recession of the Laurentide ice sheet over the last 10,000 years deposited glacial till along the surface of the Northeast, and the formation of glacial lake Vermont which deposited glacial sand/clays throughout the Windfall floodplain. The apparent cohesion of this sandy till is little to no KPa, while glacial clays have a higher cohesion value. (Bierman et al, 2020) (Fig. 5.) Landslides were most likely very active right after deposition of this material due to the absence of apparent root cohesion from vegetation along slopes, mainly of uncompacted sandy till origin. (Bierman et al, 2020) These landslides occurred as normal stress decreased due to precipitation events and pore pressures were filled, saturating the slope. Over time, the landslide activity most likely decreased, and more cohesion was implemented naturally, and the normal stress was
