# Analyzing the Extensive Landslide History of Riverside Avenue

By Skylar Alger, Liviya Kovacevic, Ryan Sauer, & Elijah Schreiber

November 2020  
Geology 151

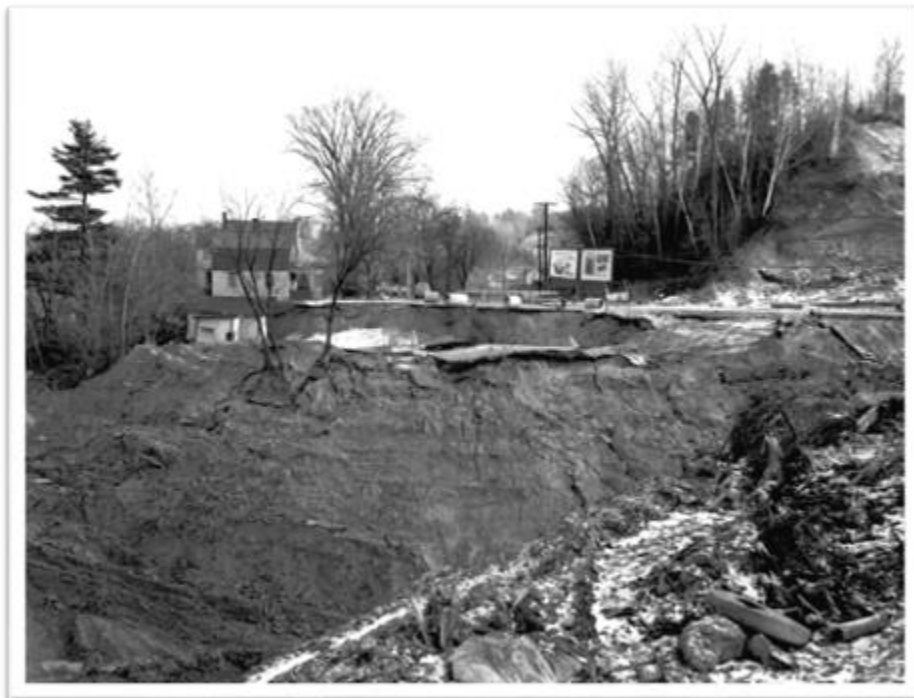
Figure 1: Historical photograph of the 1955 slide slightly down the slope from Riverside Avenue

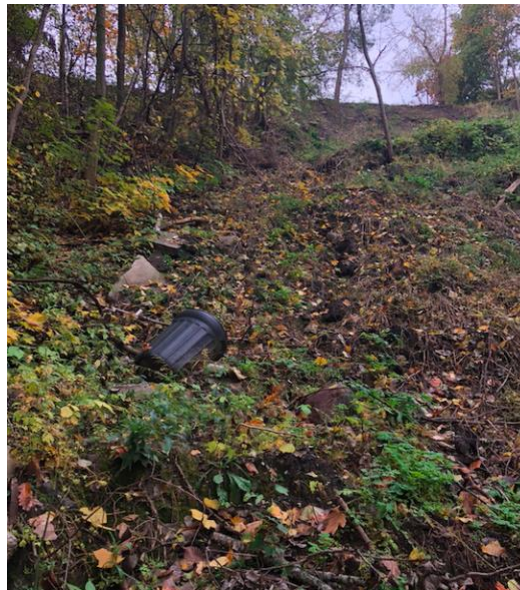
Figure 2: Image of the steep slope where the 2019 landslide occurred. Various debris including trash and concrete are visible.

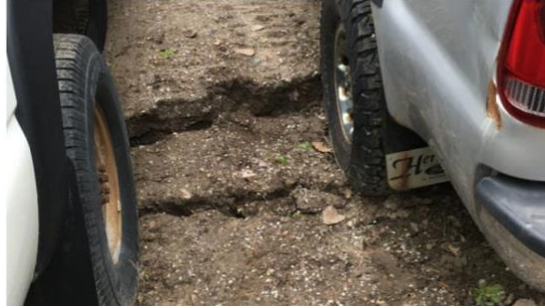
Figure 4: From Burlington Free Press showing a 6-inch gap starting to form, leading to a crack and shortly before the 2019 Halloween night landslide occurs.

There is no doubt that the Riverside Avenue landslides are impacted by human activities. Construction is one of the major ways that humans have influenced the occurrence and frequency landslides. In 1931, the city of Burlington began to widen the road and add sidewalks. The development continued into the late 1940's when small buildings were built along the road. Several landslides occurred between then and the early 1980's when more development started to occur. The steep slope along Riverside Avenue would not support the amount of development occurring over the past 100 years, which led to several major landslides. Initial construction and filling were followed by private owners illegally dumping trash and fill down the slope, which further decreased the slope stability and made the area more vulnerable to landslides. Figure 4 is an example of one image that showed gaps forming along pavement at the top of the slope shortly before a landslide occurred.

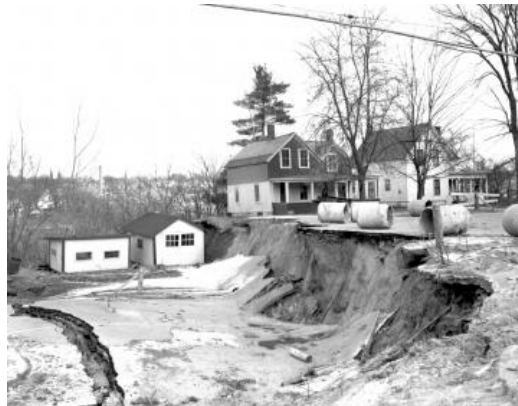
Figure 5: Image taken in 1955 after a landslide on Riverside Avenue significantly lowered a section of the road and small buildings.

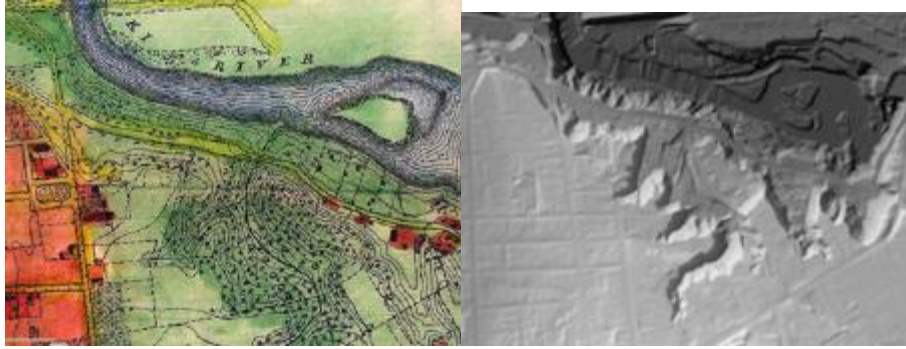
Figure 6: (Left) Topographic map of Riverside Ave from the US Coast Survey, 1872. The stream channel is clearly visible.

Figure 7: (Right) DEM of Riverside Avenue, 2004. Several landslide scars are visible between Riverside Avenue and the Winooski River.

Surface and ground water hydrology are essential components that help contribute to the rich landslide history of Riverside Avenue. In Figure 6, we see a stream channel that runs under Riverside Avenue and into the Winooski River. Figure 7 shows that the stream channel and several smaller channels spread out along the length of Riverside Avenue. Because both the filled area and surrounding soils are primarily sandy and have a high permeability, most rainwater infiltrates into the soil and moves downslope. The topography directs a decent portion of groundwater north towards the filled area, which helps reduce the strength of the slope during a storm. Since the soil is very permeable, water from heavier storms infiltrates deeper into the soil in a short time period compared to more clay rich soils. A higher saturation depth will decrease the stability of a slope to a greater extent and help trigger shallow landslides.
