GEOL 151/GEOG 144

23 November 2020

Strategies for Mitigating Landslides: A Case Study on Riverside Ave Burlington, Vermont

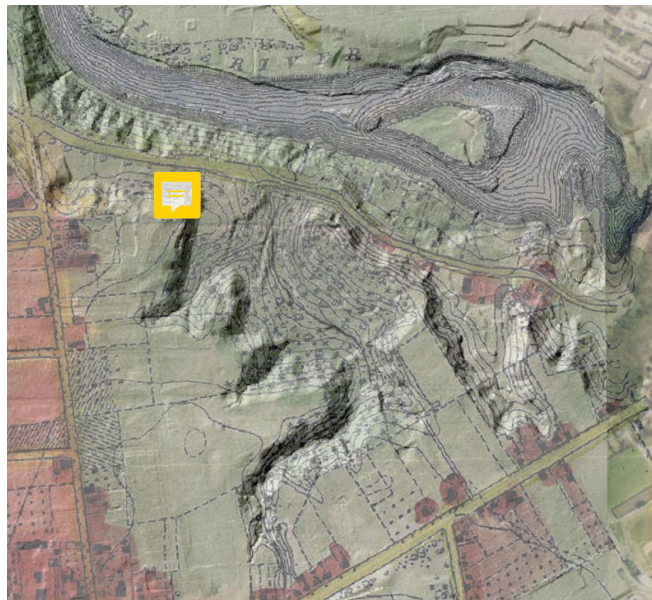
Figure 1:
1872 map overlaid with a 2014 hillshade derived from LiDAR.

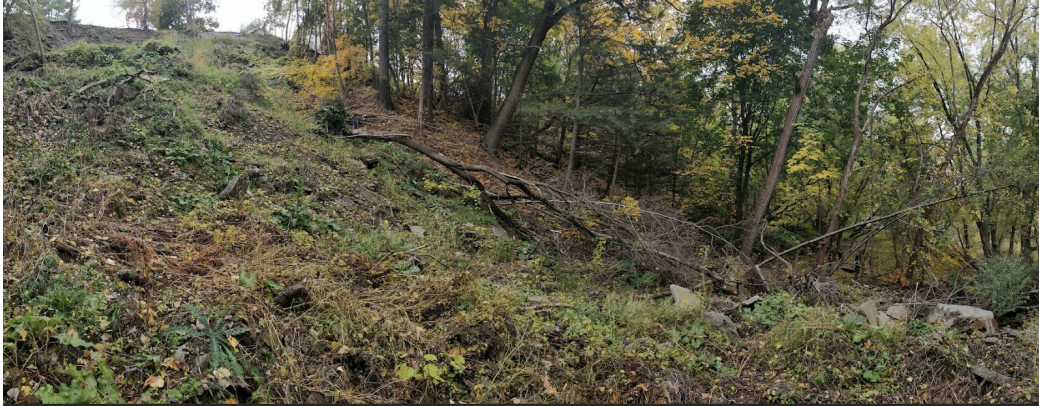
Figure 2:

Panorama of where the 2019 landslide had occurred was taken roughly a year later. It's worth noting that a lot of vegetation has regrown, however, no maintenance has been put into place except for some riprap stones at the very top of where the parking lot meets the edge.

e Ave likely due to poor maintenance that was set-in place (Bierman et al., 2005). The 2019 Halloween slide likely occurred due to the over saturation of the soil due to heavy precipitation. The steepness of the slope and thick slab material such as parking lots, buildings, vehicles, and other impervious surfaces was likely a contributing factor to why the landslide occurred. Aerial and ground level photos show that prior to when the 2019 landslide occurred, there a

n't that many trees present on the slope and the ones that were on the slope showed signs of pistol butting.

Most of the vegetation before the 2019 landslide consisted of small vegetation like grass and shrubs with a few trees. The lack of strong tree root cohesion likely was a contributing factor to the landslide. Major amounts of run-off likely occurred because the majority of surfaces above the slope were and still are pavement and hard compact gravel. Almost all of the landslides that happened did occur at the same location as the 1928 landslide; located on the edge of a major ravine shown clearly in Figure 1. More landslides happened in 1955, 1968, 1972, 1976, 1981, 2000, and most recently in 2019. Human presence is also a major factor for why many landslides have occurred. Throughout the 20th century more housing, commercial buildings, and impervious surfaces like paved roads and parking lots have caused more shear stress on Riverside Ave hillslope.

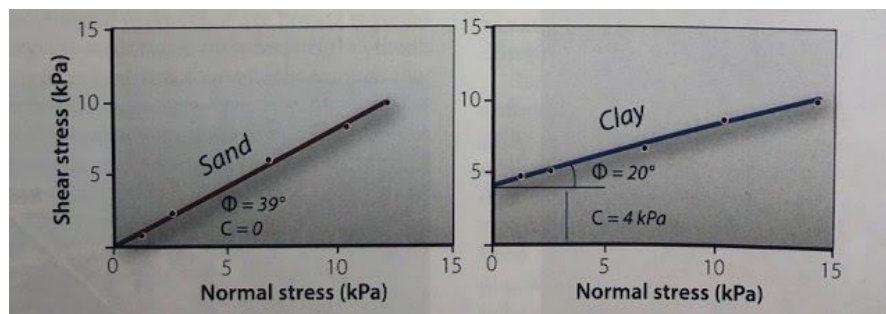
Figure 3:

(Bierman and Montgomery 2020)- The relationship between normal stress and shear stress on sand-based vs. clay-based hillslopes; clay has the higher y-intercept value due to its cohesive properties and its resisting force on shear stress.

sediment, to stick to itself-and friction make up what is shear strength. More porous soils, such as those with higher sand content, have lower cohesion compared to less porous soils that contain more silt and clay and thus are more prone to sliding (Figure 3).

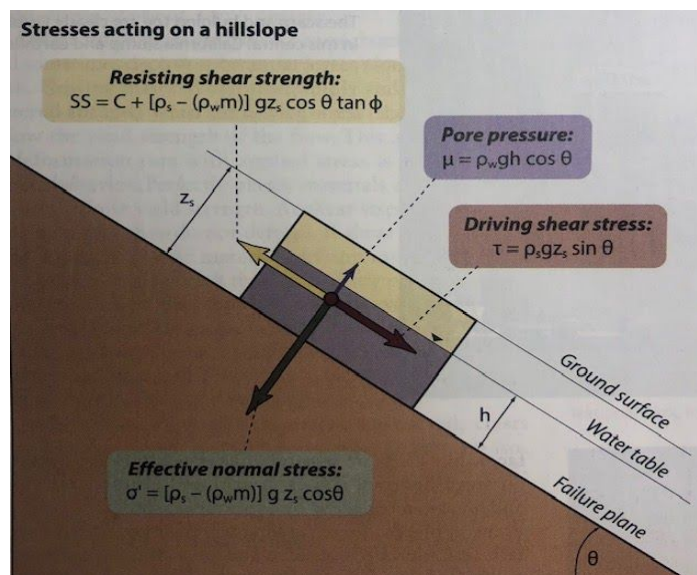
Figure 4:

(Bierman and Montgomery 2020)- The directional forcings and relationships between shear stress, shear strength, pore pressure, and effective normal stress.

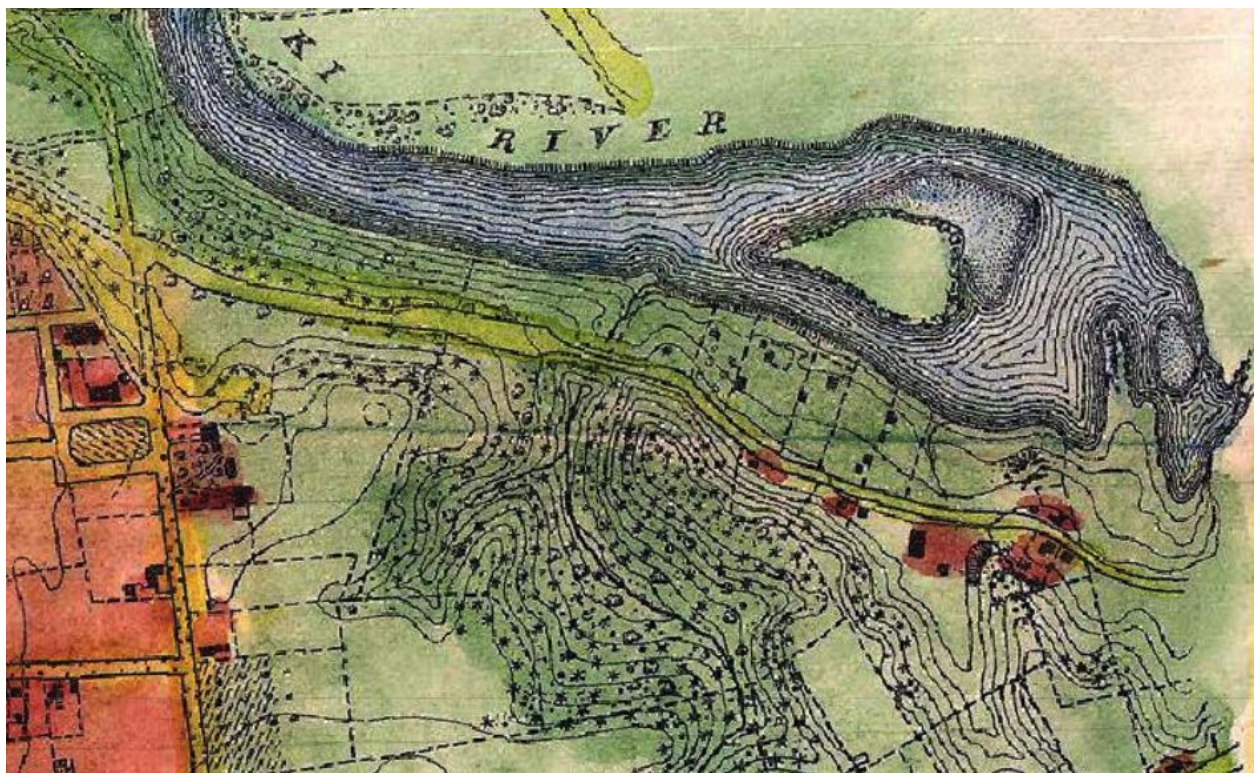
Figure 5:
1872 Geological Survey map of Riverside.

Riverside Avenue runs parallel to the Winooski River, a factor which plays heavily into the area's instability. An 1872 map shows a narrow stream running from the South to the North side of the road down to the river. In combination with the steep slope of the hill, the moving water in this stream encouraged erosion. Soils in the Burlington/Winooski area are mostly deposited glacial sediment left by the retreating Laurentide ice sheet, which is in large part low-cohesion till. The loose nature of the Riverside hill soil only encouraged both gravity and infiltration-based erosion, especially when combined with the loose sand and gravel placed there in attempts to stabilize the slope starting in the 1930s. In the area's 1955 slide, water from an unused culvert further eroded the road foundation, causing the slope to cascade into the river bed. Though the landslide-prone nature of the area is in part due to the dumping outlined above, most slides were triggered by precipitation events, which both led to heavy natural runoff and led to flooding of sewage and pipe systems.

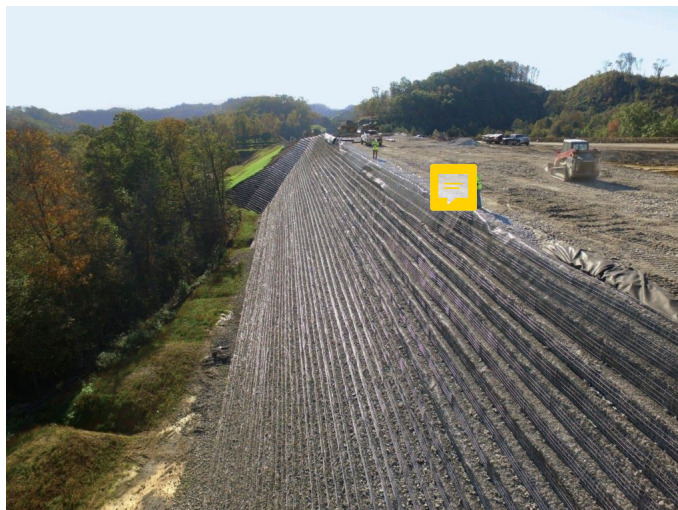
Figure 6:

A reinforced soil structure being constructed.

There are many steps that need to be taken in order to minimize the occurrence of landslides in the future. Over the years, maintenance crews have done a relatively poor job in constructing effective slope stabilizers. Whether this has to do with a lack of funding remains unclear, however, there are many ways in building effective slope stabilization techniques. One technique for reducing the risk of future landslides could be improving surface and subsurface drainage systems. The overflow of runoff is a large factor for landslides and improving these systems can stabilize a landslide-prone slope. In order for this to work, a drainage channel needs to be put into place to divert the surface water away from the landslide region. This will make sure that water doesn't accumulate near the landslide prone area (Kansas Geological Survey, 1999). Another technique is removing the soil and rock at the head of the where the landslides occur so that the driving pressure is reduced. In the case of Riverside Ave, this wouldn't be an adequate technique because the businesses, housing, parking lots, and roadways that are all resting on the flat before the slope pitches. Buttressing the toe is another technique where fill is added at the toe (bottom) of the hillslope so there are resisting forces to stop landslide debris. Creating some sort of barrier at the bottom of the hillslope would also prevent any soil from leaching into potential nearby water bodies like the Winooski River. Preserving vegetation on landslide hillslopes can also have a huge impact on increasing soil cohesion due to root structure holding the soil, but also reduce the amount of water that percolates through the soil causing erosion to occur. Reinforced soil structures like geogrids can be effective slope stabilizers. Geogrids are constructed by placing alternative layers of metal reinforcement and compacted soil to create a structure hindering lateral forces (Mandavkar and Weldu, 2019). Ancient soil-reinforcement used any materials like tree branches and straw, however, modern reinforcement elements include steel grids, wire meshes, or geotextile sheets. The image below showcases what a geogrid looks like followed by a diagram explaining how it functions:

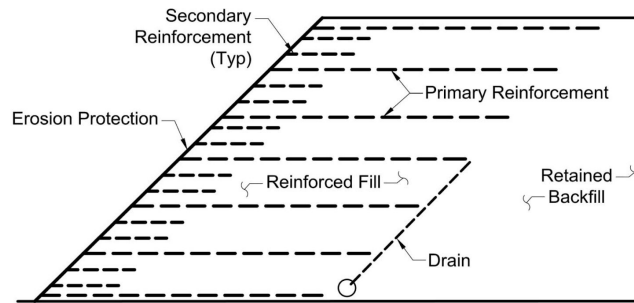
Figure 7:
 Diagram showing how a reinforced soil structure functions.
 Source: (Mandavkar and Weldu, 2019)
