Landslides along the Winooski River in Burlington, Vermont: Landscape change and slope instability

Shayla Triantafillou, Anne Morrison, Emily Mischler, Jason Drebber
Department of Geology, University of Vermont, Burlington, VT, USA

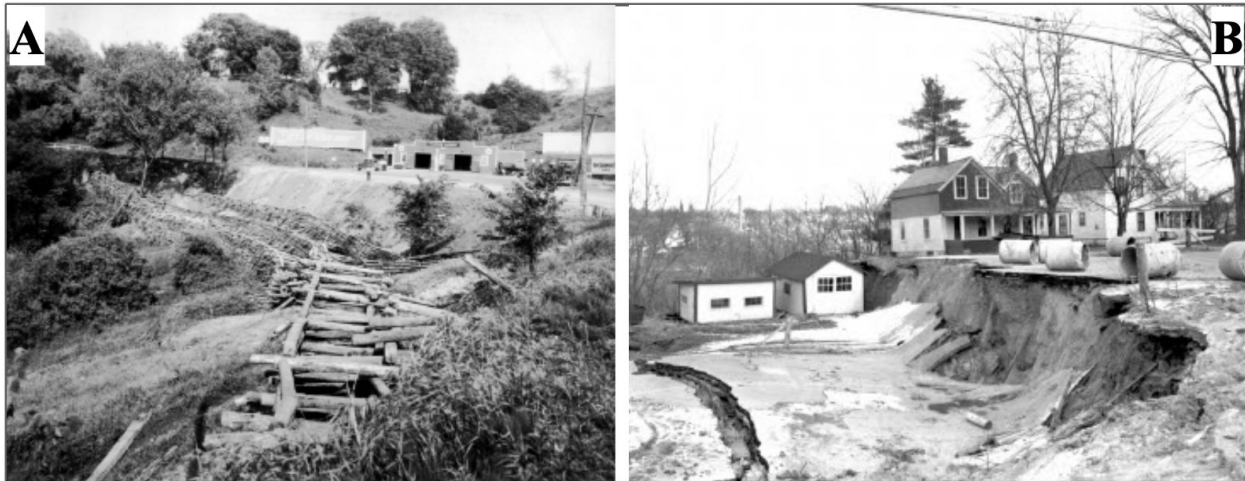
Figure 3: **A)** Historic photograph of road widening with wooden shorings and fill from early 1930 on the north side of Riverside Avenue. **B)** December, 1955 Riverside Avenue landslide. Sourced from the UVM Landscape Change Program website. Photo credit: A) L.L. McAllister, B) James Detore

Anthropogenic landscape changes are the primary cause of landsliding along Riverside Avenue by altering the force balance of the slope (Fig. 2). Significant road work began in 1930: filling and widening the road by over 1.5 meters (Fig. 3A, *Street Department, 1931*). Historical photos reveal houses, businesses, and parking lots were constructed on both sides of the road between 1930 and 1955 (Fig. 3A,B). Eventually, the surficial geology alongside Riverside Avenue became primarily sandy fill deposited by humans. The first documented landslide occurred in 1955 (Fig. 3B). The slope instability was exacerbated in the 1970s and 1980s when trash was illegally dumped down the slope on the northern side of Riverside Avenue triggering landslides (Melvin, 1983). Trash and construction waste (Reilly, 1981) on the slope increase slope angle and soil-slab thickness which intensify driving shear stress (See Appendix).

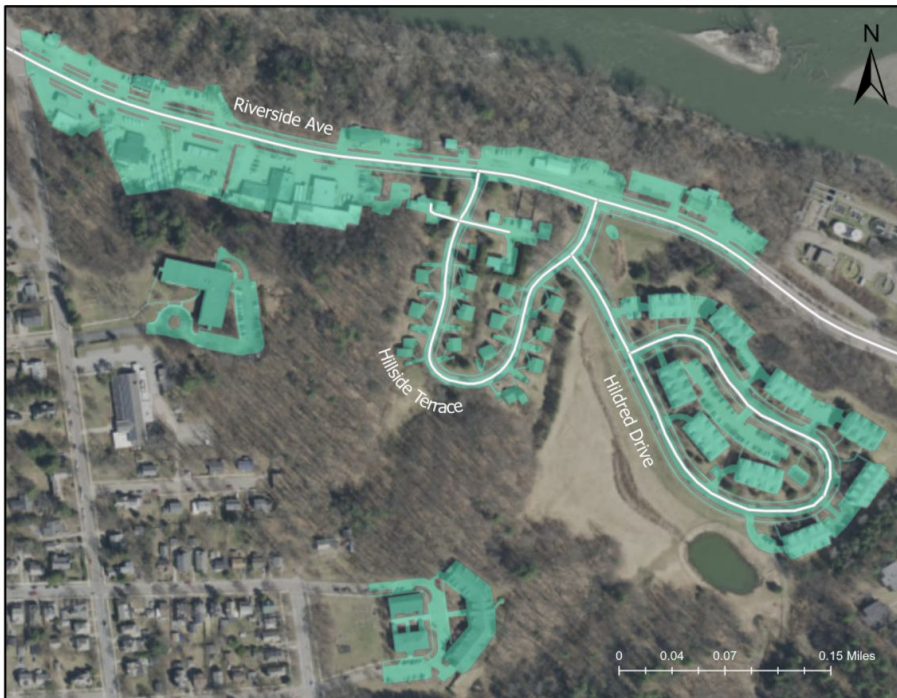
Figure 4: Map of impervious surfaces (pavement, buildings, etc.) on Riverside Avenue contributing to high volumes of runoff within the study area. Approximately 27% of the area that drains in the direction of the study area is impervious. Sourced from ESRI World Imagery basemap and VCGI road data.

The site's drainage basin topography is depicted in Figure 1. Approximately 27% of Riverside Avenue and surrounding neighborhoods within this drainage basin consists of paved or impervious surfaces (Fig. 4). Shifts in runoff response due to changes in land use are visible in a

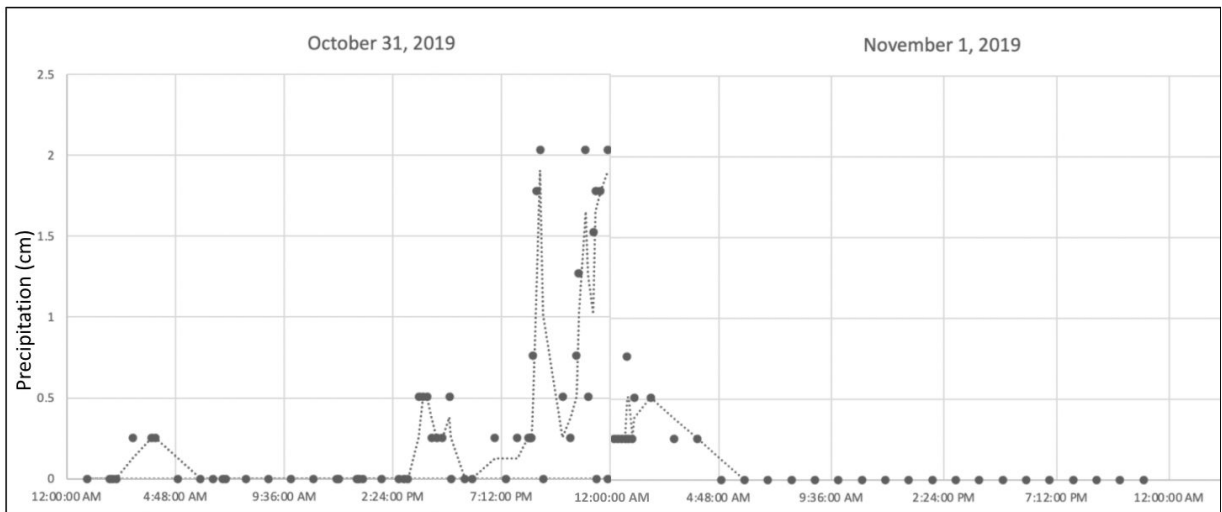
Figure 6: Precipitation measurements including a moving average of precipitation at the Burlington International Airport weather station on the night of the Riverside Avenue landslide in 2019. Data sourced from Weather Underground, VT Weather History.

Most landslide events are associated with large storms as a catalyst (*Driving Rain Causes Landslide, 1959; Washout Rips Riverside Ave., 1955*). Most recently, the October 31st, 2019 storm (Fig. 5, Fig. 6) saturated the soil past a threshold triggering a landslide. This storm event was of high intensity and duration and produced ten centimeters of precipitation from the afternoon of October 31st to the morning of November 1st (Fig. 6). While this was a large storm in Vermont, we calculated a flow recurrence interval of only 3.44 years at the Essex Junction stream gage. Therefore, there is a 29% chance that an event of this size will occur in any given year.
