*Human Activity as the Primary Indicator of Increased Frequency and Spatial Distribution of Landslides on
Riverside Avenue in Burlington, Vermont, 1928 - 2019.*

Hehlen, Mark. Long, Grant. Robinson, Emma. Silvia, Kate.
Fall 2020 Geomorphology
University of Vermont

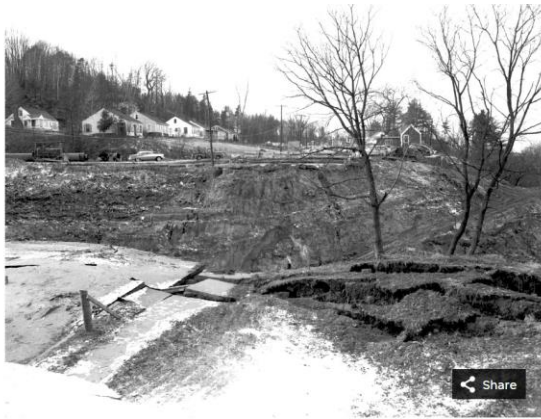
Figure 2: Insurance photo from the historic 1955 landslide that wiped out the middle of Riverside Ave. News reports account the road detour through a landfill. From "History of a Slippery Slope" 2019.

In 1955 two landslides occurred at what is now the intersection of Riverside Avenue and Hillside Terrace. Riverside Avenue required extensive repairs after a massive washout from the first landslide (**Figure 2**). A third landslide occurred from toploading of excavation soils (*Washout Rips Riverside Ave Third Time*, 1995), overburdening the crest of the slope to the point of failure. In 1960 the landfill was cleared out, in order to make room for housing developments (see 1962 aerial photo in **Figure 3**) increasing rainfall runoff in the area.

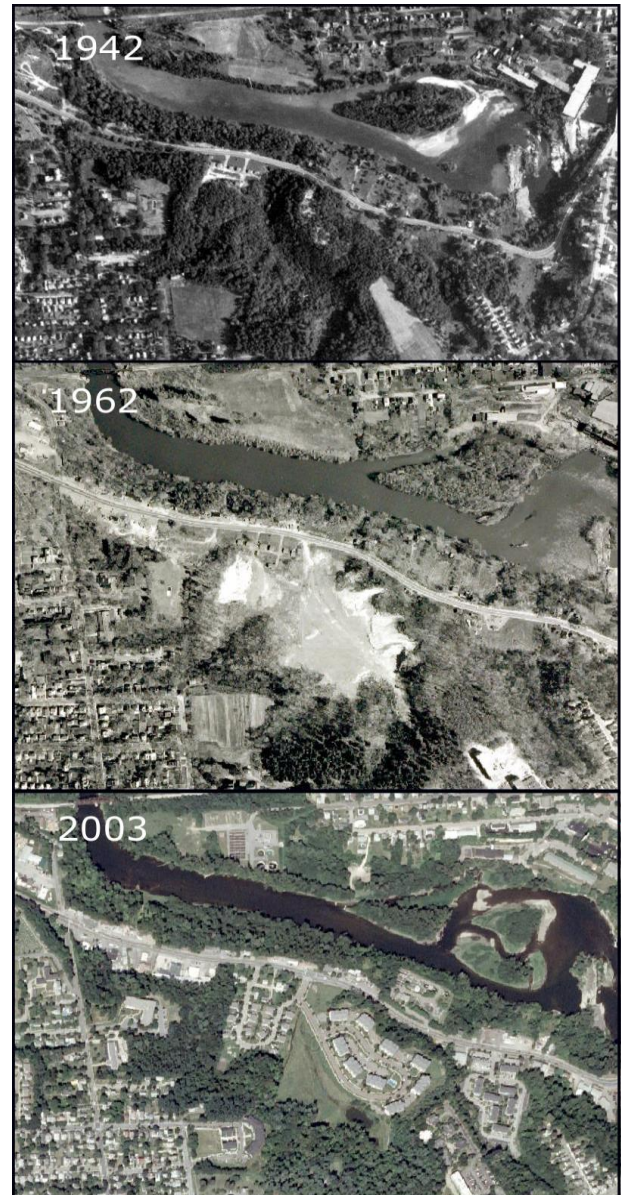
Figure 3: Three photos showing Riverside Avenue land development from 1942-2003. Well-forested in 1942 with development on the eastern end of the road. 1962 shows extensive deforestation for development. 2003 shows development on both sides of the road.

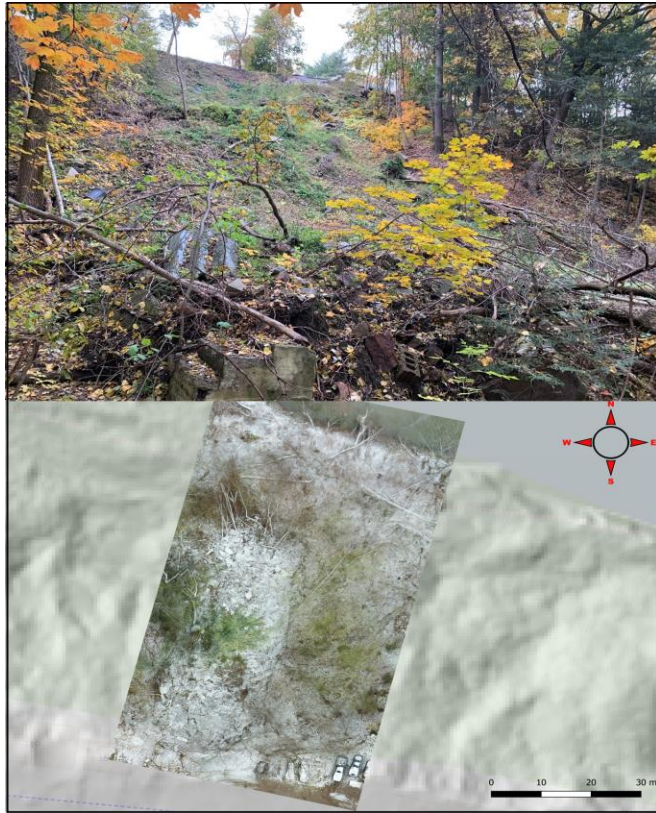
Figure 4: In-situ photo of the Halloween 2019 landslide and orthographic LiDAR imaging of the site. Photo by Emma Robinson. Drone imaging by UVM Remote Sensing Lab.

strength). In late October of 2019, a large storm poured 3.3 inches of rainfall in Burlington over a 24-hour period. This led to slope saturation and the ‘Halloween’ landslide of 2019 (Figure 4).

We gathered *in situ* measurements of slope angle and debris field volume, while using orthographic LiDAR data to map the spatial extent of the scarp. The area of the 2019 landslide covers nearly 3500 m² on a 30° slope. A ~3000 m² backfilled and paved property sits on the hill crest and drains upon it. Measuring the debris field volume, we estimate a slab displacement of 3595-5000 cubic meters. Observed debris consists of sandy soils, shrubbery, tires, cement blocks, and trash.

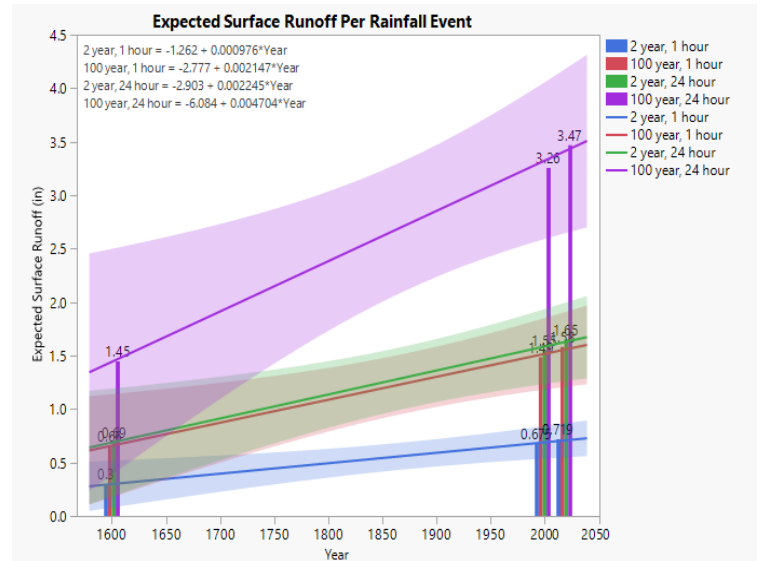
Urban areas incur excess runoff due to impermeable pavement and developments. Runoff on Riverside Avenue is no exception. The down sloping road with limited drainage leading off the road and into the sewer system or river. By analyzing land-use change in Burlington, runoff percentage, and storm recurrence rates, we can see a clear trend in increased runoff (**Figure 6**) that will threaten unstable slopes - and the buildings on them - more often in the future.

Figure 6: Expected Surface Runoff in Burlington, Vt. Runoff increases with land use change and urban development. Made with calculated data from Burlington Orthophotography and Rainfall recurrence events from US Department of Commerce and Weather Bureau (1959)
