# Analyzing the Extensive Landslide History of Riverside Avenue

*By Skylar Alger, Liviya Kovacevic, Ryan Sauer, & Elijah Schreiber*

4 December 2020  
Geology 151 - Geomorphology

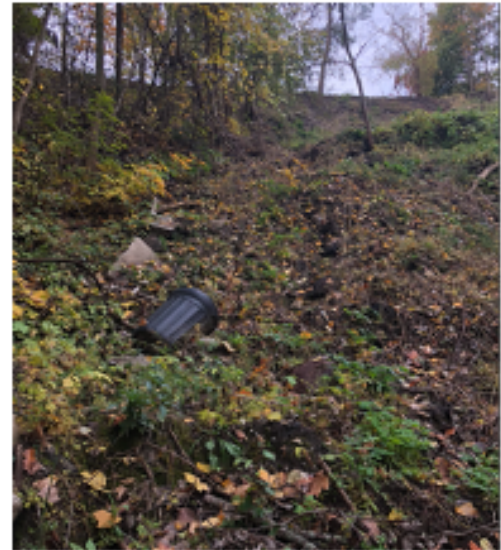
Figure 2: Image of the steep slope where the 2019 landslide occurred. Various debris including trash and concrete are visible (Liviya Kovacevic 2020).

The topography of Riverside Avenue combined with the fill material are significant contributors to the reoccurrence of these landslides. At the site of the 2019 landslide (Figure 2), we observed a slope angle near  $30^\circ$  that was composed of a various aggregate of fill materials including old junk objects, sands, and gravels that impact soil properties and decrease stability. Additionally, several old streams and culverts, some of which are buried under Riverside Avenue, contribute to the saturation of the slope and decrease its shear strength. During heavy rainfall events, a large flux of groundwater is moved by the culverts to further saturate the filled slope. This combination of topography, fill composition, and slope saturation set up the area for numerous disasters.

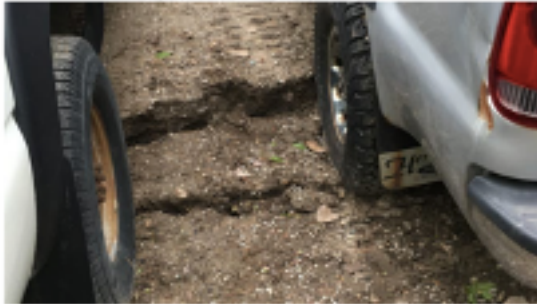
Figure 5: A 6-inch gap begins to form, cracking shortly before the 2019 landslide occurred (Paul Bierman 2019).

development began. Eventually, the steep slope along Riverside Avenue could not support the amount of development occurring, leading to several major landslides. Initial construction and filling were followed by private owners illegally dumping trash and fill down the slope (Newspaper Clippings), which further decreased the slope stability and made the area more vulnerable to landslides. Figure 5 is an example of a precursor to landslides, taken shortly before the 2019 landslide.

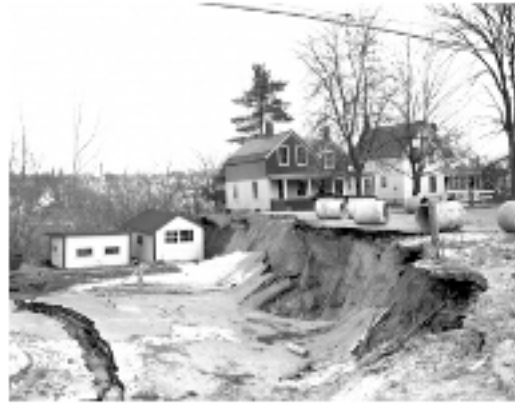
Figure 6: Image taken in 1955 after a landslide on Riverside Avenue significantly lowered a section of the road and small buildings. (UVM Landscape Change Program).
