Geomorphology and Landslides Along Riverside Avenue

GEOL 151 Professor Paul Bierman

Adam Gellman, Freddy Larsen, Reshma Rampersaud and Brenda Waters

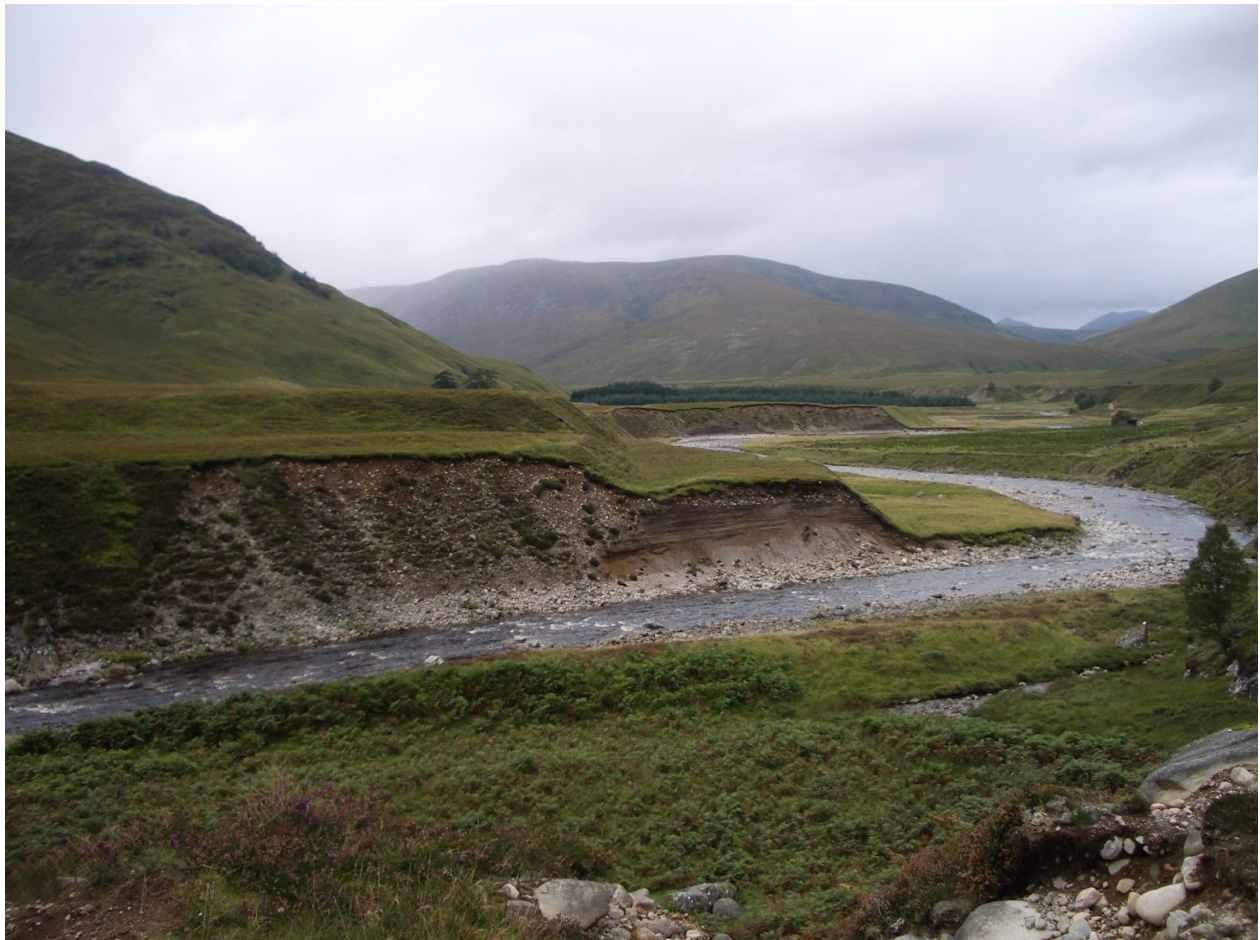
Figure 1: A degradational terrace with a steep, unstable slope on the far side of the river
Photo sourced from Bethan Davies, 2004

After the retreat of the Laurentide ice sheet, a thick layer of glacial lake sediment and till occupied much of the Champlain Valley. When river systems reestablished, they incised into sediment of the lower valley (Roussel, 2018). Along the Winooski River, steep slopes and degradational terraces were formed in the sediment banks along what is now Riverside Ave. Figure 1 shows how river incision through glacial sediments creates steep and unstable slopes of glacial sediment and till (Phillips, 2005). These slopes eventually stabilized through forestation, soil creep and other processes over thousands of years.

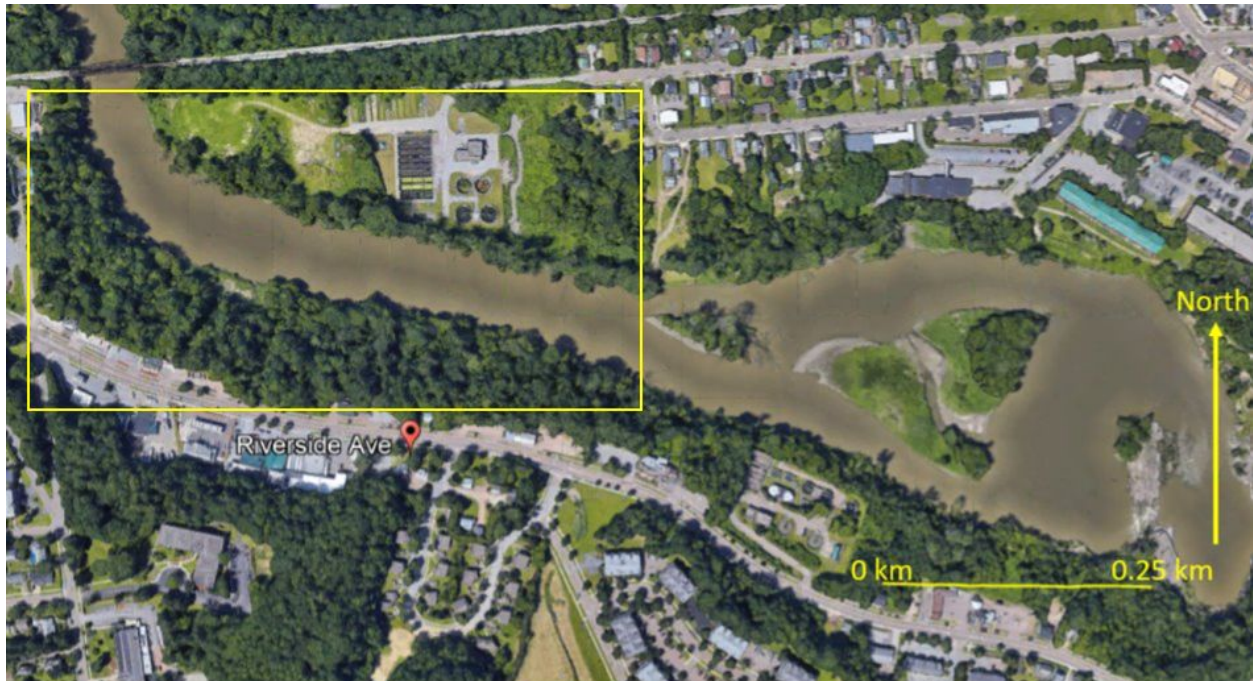
Figure 4: This image of Riverside Ave shows the extensive development and impervious surfaces built on the edge of a 76m high slope leading to the river. The yellow rectangle represents our study area. *Photo sourced from Google Maps, 2020.*

To the first engineers constructing Riverside Avenue, the steep slope north of the road was not a concern as the mature forest was a clear sign of slope stability. However, with development, the river bank now comes as close as 76 meters from the edge of the pavement in some areas. With an estimated relief from river to road of 37.5 meters, slope in some areas may be as steep as 26 degrees. Near the intersection of Riverside and Intervale Avenues the river bends to the north and tends to emplace a cutbank. All these conditions conspire to make the north side of Riverside Avenue a perfect setting for landslides. Prior to human intervention, landslides were likely rare and small, but with deforestation, paving and dumping of fill, landslides became larger and more frequent. Now, they pose imminent danger to properties in

this area. Most of the landslides have occurred along the western half of the Avenue where the slopes are steeper. Moreover, applications of fill occurred primarily in this region, which significantly decreased resisting shear strength of the slope's material, thereby reducing the resisting forces and increasing the chance of slope failure.
