## Strategies for Mitigating Landslides: A Case Study on Riverside Ave Burlington, Vermont

GEOL 151/GEOG 144

4 December 2020

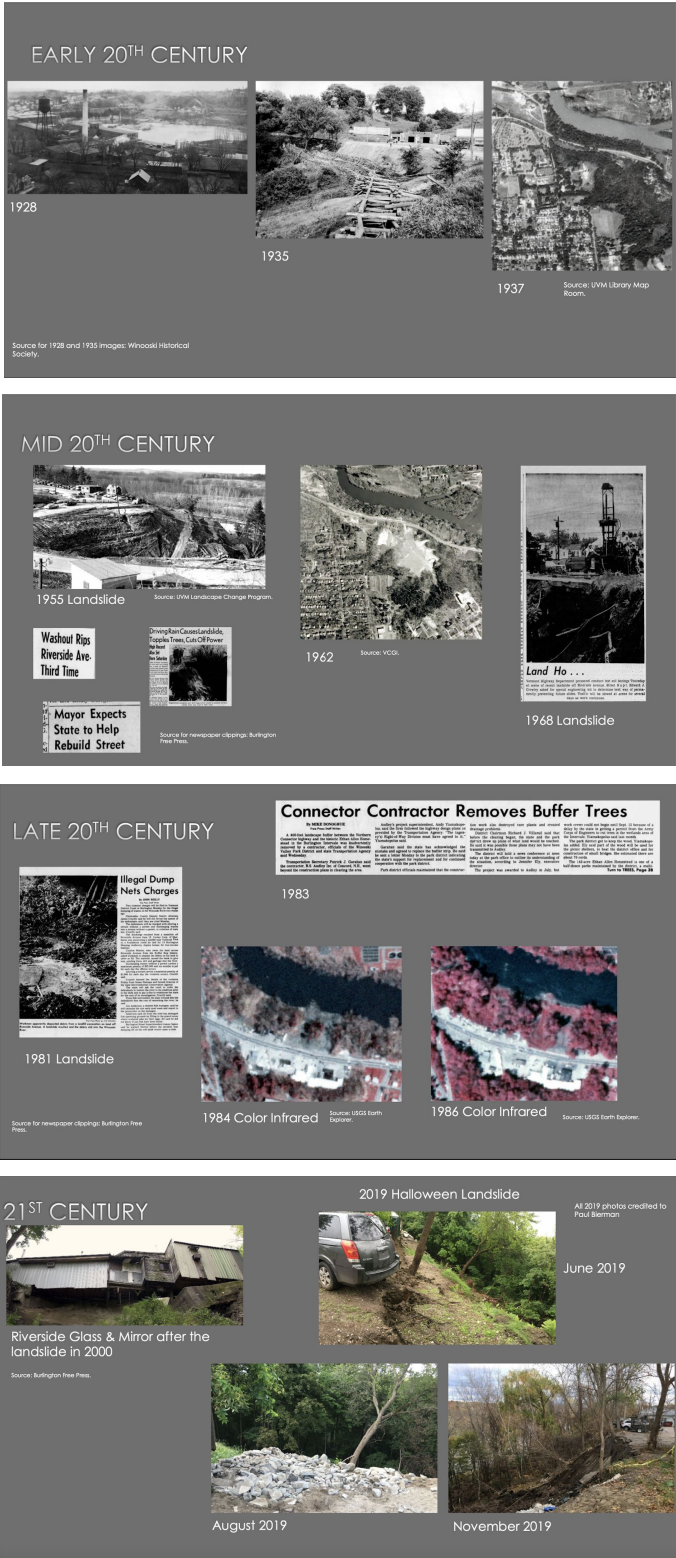
**Figure 1:** Timeline of landslides along Riverside Avenue. The first recorded landslide was in 1928, while the most recent occurred in 2019.

Many landslides have occurred along Riverside Ave over the past century (Figure 1). Throughout the 20th century, more housing, commercial buildings, and impervious surfaces like paved roads and parking lots have caused more shear stress on the Riverside Ave hillslope. The distribution of landslides along Riverside Ave is the result of differences in the topography. More specifically, the distribution relies on pockets of low shear stress thresholds, poor soil cohesion due to lack of vegetation, and areas where the water table could condense runoff. The interplay of these main topographical characteristics determines how likely areas are to surpass their thresholds for sliding when acted upon by forces like heavy rain, weight bearing, and weathering. As visible in Figure 2, certain areas exhibit a colluvial fan pattern in which steep walls splay out into more gently sloped fans—these areas are hotspots for sliding. The distribution of these hotspots happen naturally, but further along, this paper will address the role of human intervention in accelerating, decelerating, and moving these hotspots. Below is a timeline showcasing the landslide history of Riverside Ave.

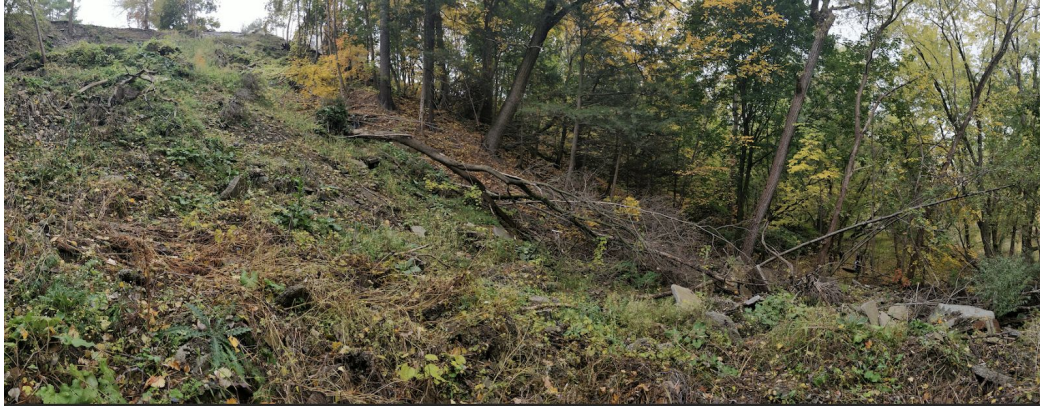
**Figure 3:**

Panorama of where the 2019 landslide occurred (taken in October 2020). It's worth noting that a lot of vegetation has regrown, however, no maintenance has been put into place except for some riprap stones at the very top of where the parking lot meets the edge.

Both natural and human factors have contributed to landslides along Riverside Ave. After the first recorded landslide of 1928, wooden cribbing was used along with fill to stabilize the slope. Later, rocks were placed on top of the fill before the area was paved to rebuild the street. The 1955 landslide likely occurred due to less cohesive materials like fill and a combination of both poor maintenance and increased urbanization (Bierman et al., 2005). The 2019 Halloween slide likely occurred due to the over saturation of the soil from heavy precipitation. The steepness of the slope, combined with the impervious nature of pavement, hard compact gravel parking lots, roads, and other impervious surfaces above the hill were likely a contributing factor to the landslide, as they increased run-off volume. The extent of the 2019 landslide is visible in Figure 3. The lack of strong tree root cohesion was likely also a contributing factor to the landslide.

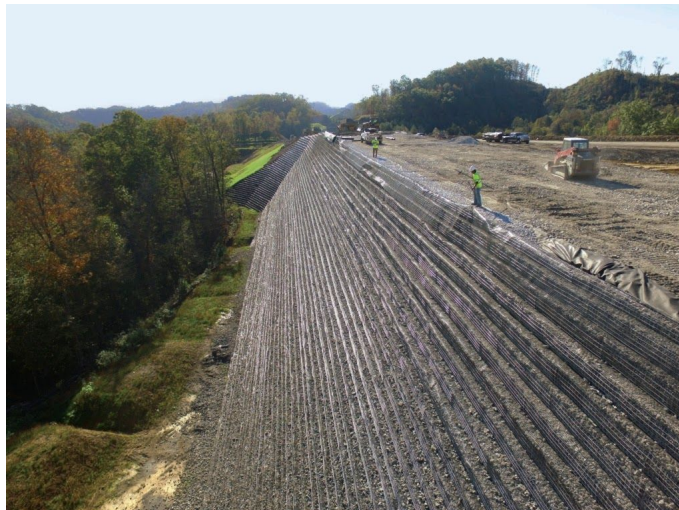
**Figure 4:**  
A reinforced soil structure being constructed.  
Source: (Mandavkar and Weldu, 2019)

region. This will make sure that water doesn't accumulate near the landslide prone area (Kansas Geological Survey, 1999). Another technique is removing the soil and rock at the head of where the landslides occur to reduce driving pressure. In the case of Riverside Ave, this wouldn't be an adequate technique because the businesses, housing, parking lots, and roadways that are all resting on the flat before the slope pitches. Buttrussing the toe is another technique where fill is added at the toe (bottom) of the hillslope so there are resisting forces to stop landslide debris. Creating some sort of barrier at the bottom of the hillslope would also prevent any soil from eroding into potential nearby water bodies like the Winooski River. Preserving vegetation on landslide hillslopes can also have a huge impact on increasing soil cohesion due to root structure holding the soil, but also reduce the amount of water that percolates through the soil causing erosion to occur. Reinforced soil structures like geogrids can be effective slope stabilizers. Geogrids are constructed by placing alternative layers of metal reinforcement and compacted soil to create a structure hindering lateral forces (Mandavkar and Weldu, 2019). These methods are relatively cost-effective with prices ranging from \$110/m<sup>2</sup> to 260/m<sup>2</sup> of reinforcement. However, this excludes both safety and drainage factors (Christopher, 2014).
