Adam Gellman, Freddy Larsen, Reshma Rampersaud and Brenda Waters Professor Bierman Geomorphology November 23, 2020

Geomorphology and Landslides Along Riverside Avenue

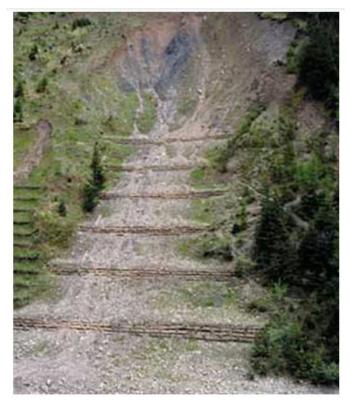
Figure 4: A crib wall check dam (Photo taken in Trafoi, Italy, courtesy of "Erosion Control" Forester Communications, Santa Barbara, CA.) It appears that the sediment storage dams are already filled.

Slope strengthening strategies may be applicable to the area along Riverside Ave. Currently, Burlington engineers could consider adding plastic mesh reinforcements and rock-fill buttresses to stabilize the slope. Given the natural ecosystem that runs through the shore north of Riverside Avenue, another approach may better apply, that of building a crib wall check dam, pictured in

This dam comprises a series of knickpoints with sediment storage dams built below each knickpoint. It is made of reinforced concrete. Spacing of the dams depends on channel gradient and dam height.
