Adam Gellman, Freddy Larsen, Reshma Rampersaud and Brenda Waters
Professor Bierman
Geomorphology
November 23, 2020

Geomorphology and Landslides Along Riverside Avenue

Abstract

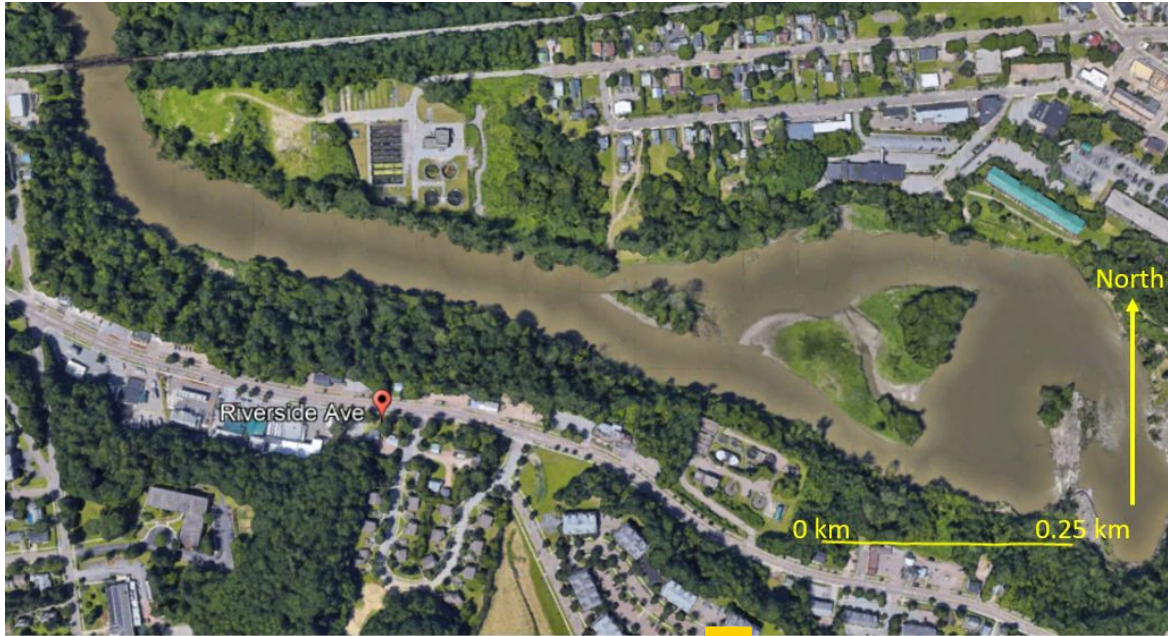
Figure 3: Image of Riverside Avenue taken in 2020.

To the first engineers constructing Riverside Avenue, the steep slope north of the road was not a concern. Mature forest reassured them that the slope would surely remain stable. However, the river bank comes as close as 95 meters to the center of the avenue. With an estimated elevation change from river to road of 80 meters, slope in some areas may have been as great as 40 degrees. Near the intersection of Riverside and Intervale Avenues the river meanders north and tends to emplacement a cutbank at that location. All these conditions conspire to make the north side of Riverside Avenue a perfect setting for landslides. Prior to human intervention, landslides were likely rare and small, but with deforestation, paving and dumping of fill, landslides became larger and more frequent. Now, they pose imminent danger to properties in this area. Most of the landslides have occurred along the western half of the segment of the Avenue studied. This region has steeper slopes. Moreover, applications of fill occurred primarily in this region, which significantly decreased resisting shear strength of the slope's material, thereby reducing the resisting forces and increasing the chance of slope failure.

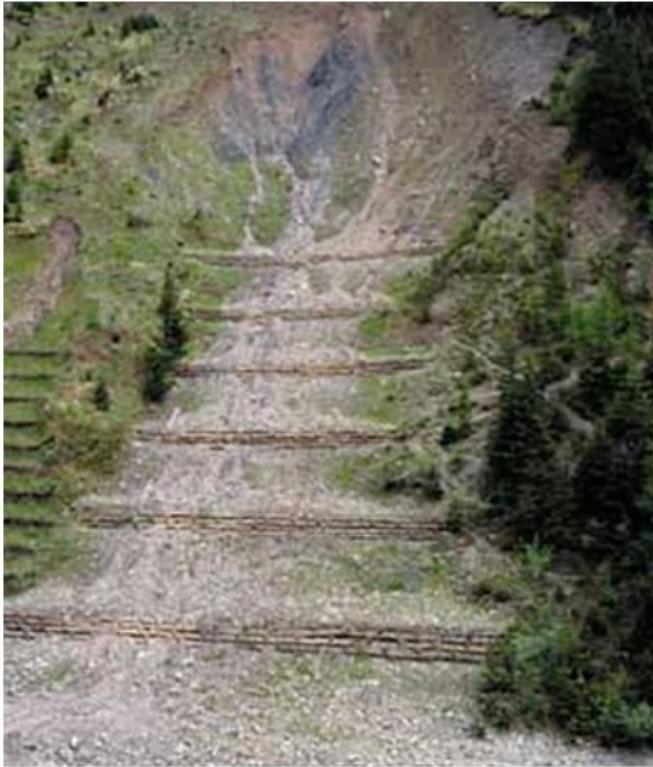
Figure 4: A crib wall check dam (Photo taken in Trafoi, Italy, courtesy of “Erosion Control” Forester Communications, Santa Barbara, CA.) It appears that the sediment storage dams are already filled.

Slope strengthening strategies may be applicable to the area along Riverside Ave. Currently, Burlington engineers could consider adding plastic mesh reinforcements and rock-fill mattresses to stabilize the slope. Given the natural ecosystem that runs through the shore north of Riverside Avenue, another approach may better apply, that of building a crib wall check dam, pictured

This dam comprises a series of knickpoints with sediment storage dams built below each knickpoint. It is made of reinforced concrete. Spacing of the dams depends on channel gradient and dam height.
